Appendix B: History of NTSF

In the late afternoon of Friday 9 March 2018, following the identification of cracks on the dam crest earlier in the day, a slump occurred on the western side of the southern embankment of the NTSF.

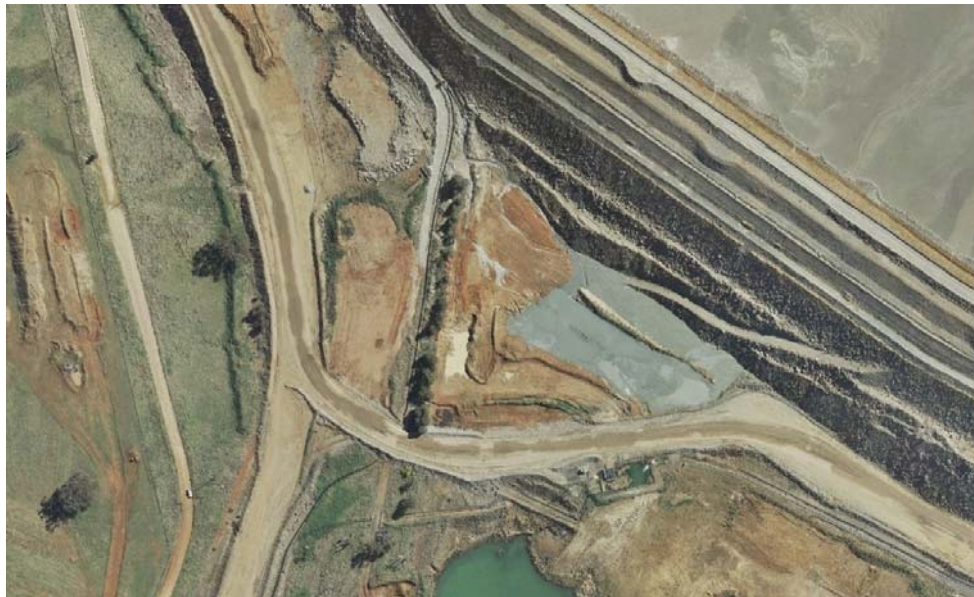
Of particular interest to the NTSF Embankment Failure investigation is Stripping Area 3, where in excess of 4m of tailings had accumulated in a depression (previously noted in Section B2.5). The extent of the tailings can be more clearly seen in Photo B2-7 after the depression had been partially excavated to make more room for additional tailings overflow.

Photo B2-7: Aerial photo of tailings filled depression (circa 2012) (2012-001)

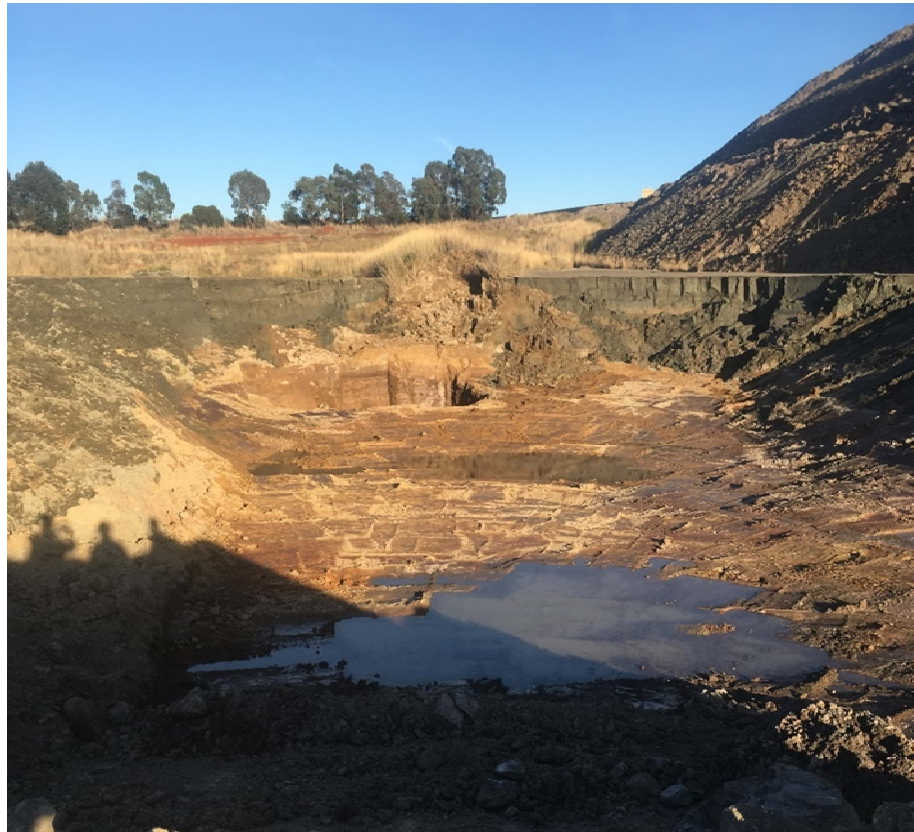
Photo B2-8 shows the exposed foundation on 18th January 2018, with excavated test pit at the western end of the excavation and seepage in foreground.

Photo B2-8: Exposed foundation on 18th January 2018 (2018-010)

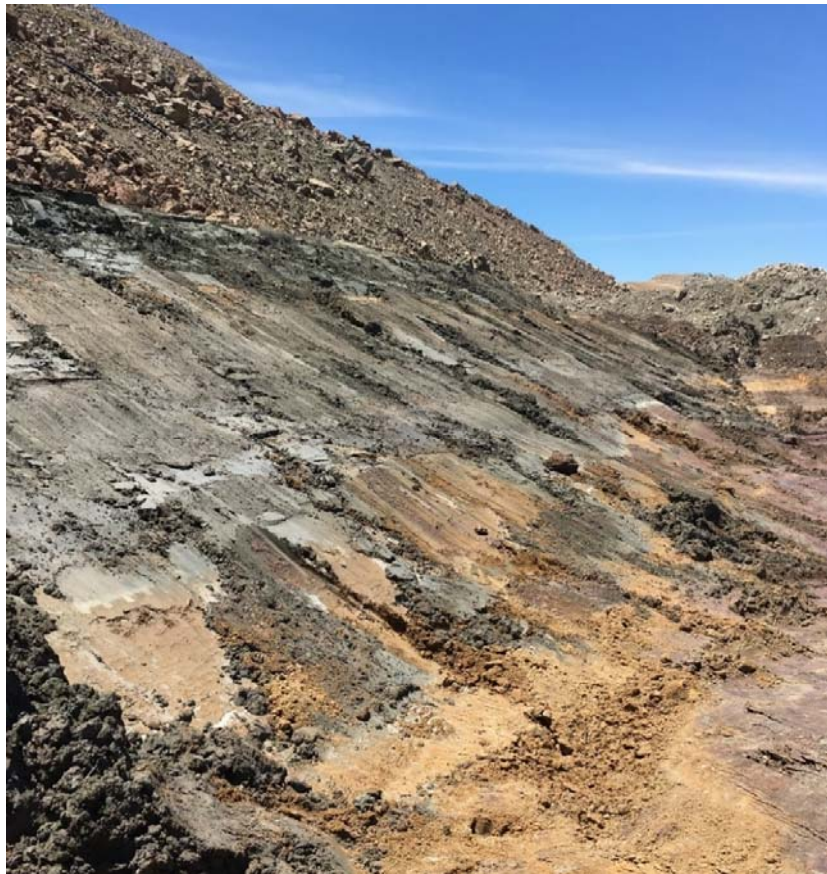
Photo B2-9: Excavated face at toe of NTSF on 17th January 2018 (2018-011)

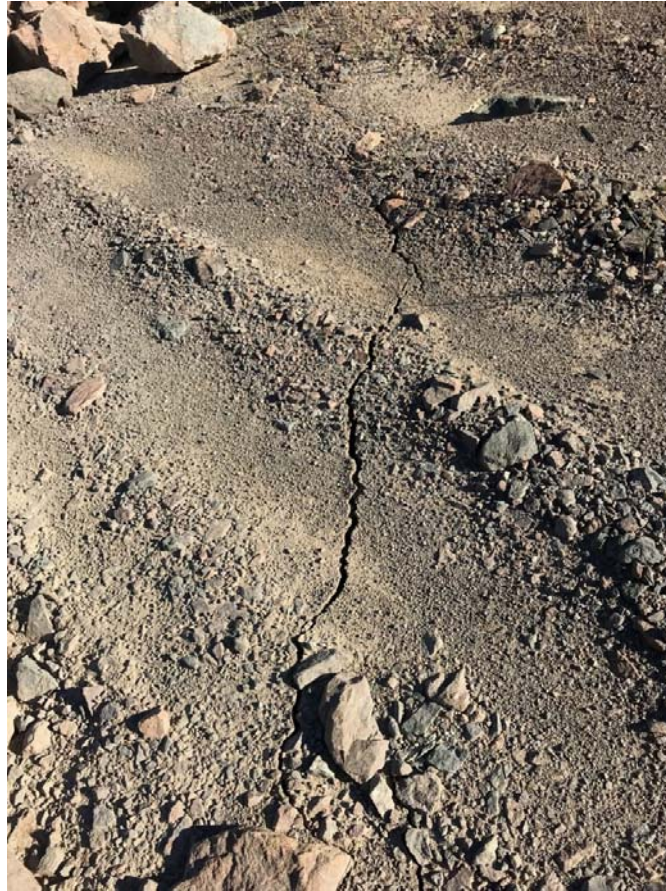
A photograph of cracking taken at 07:48 on 9 March is presented as Photo B8-1.

Photo B8-1: Photograph of cracking on Stage 5 crest taken at 07:48 (2018-012)

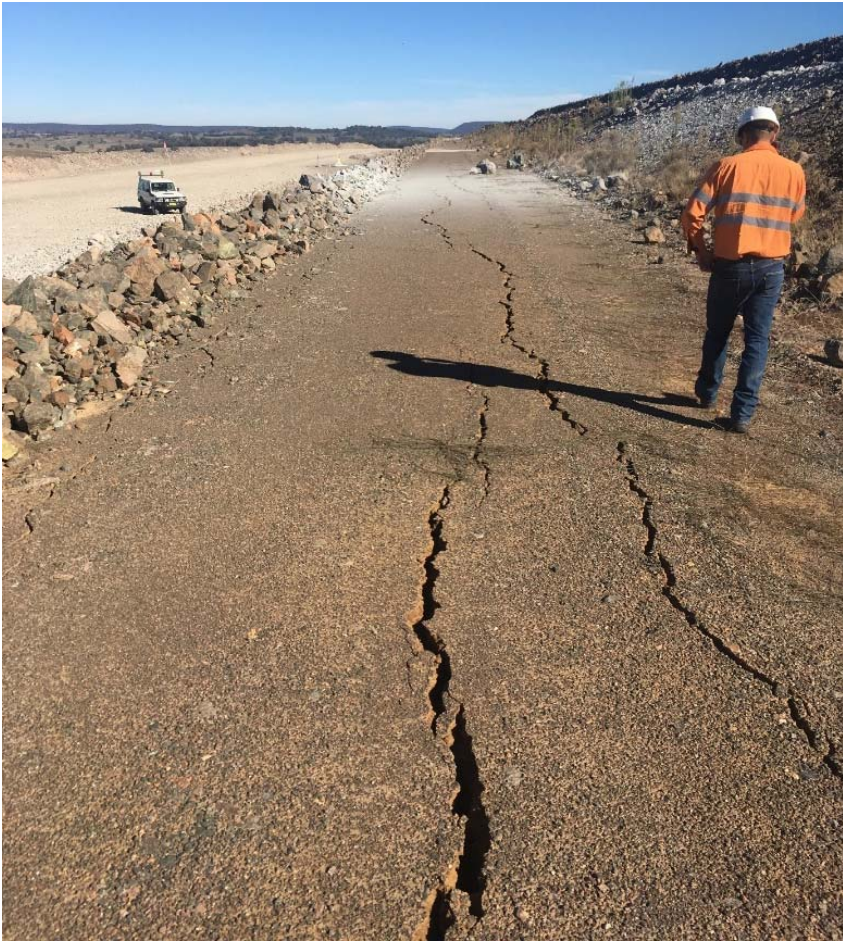
Photo B8-2: Stage 8 crest cracking looking west (2018-013)

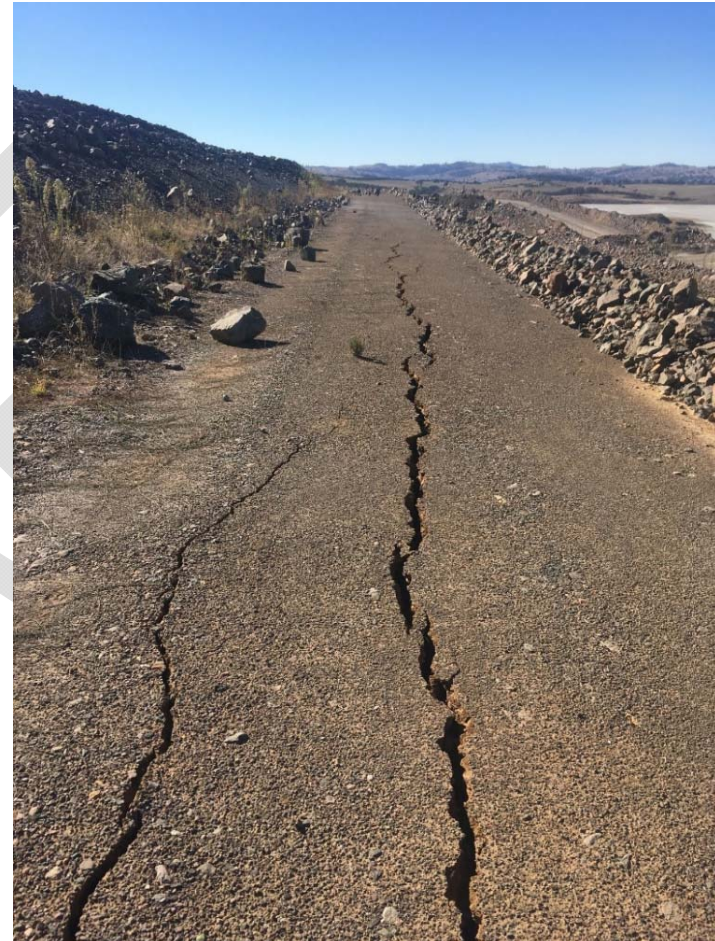
Photo B8-3: Stage 8 crest cracking looking east. (2018-014)

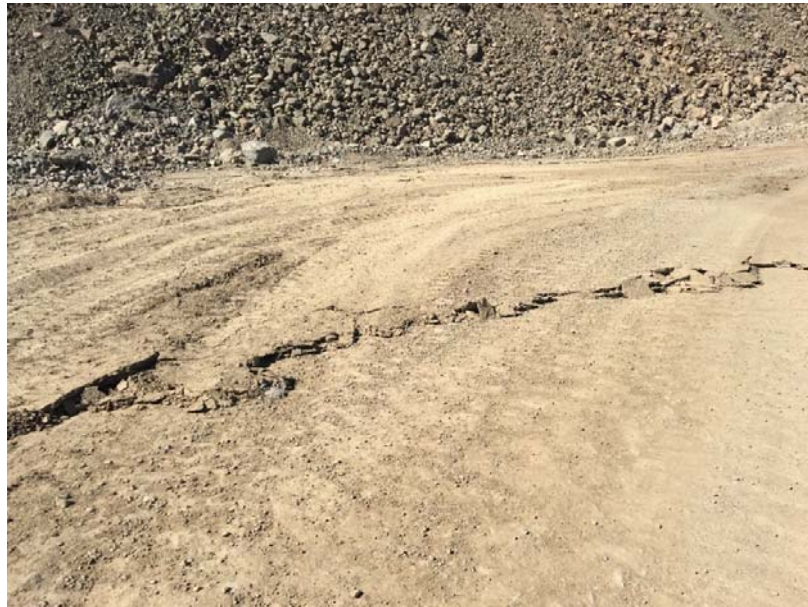
Photo B8-4: Cracking and heaving of haul road at Chainage 2060 (2018-015)

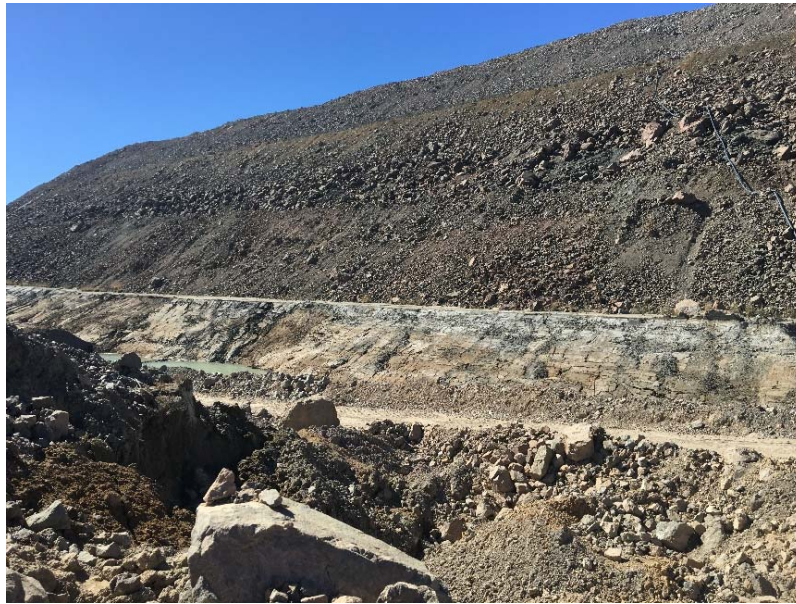
Photo B8-5: Cracking of excavated face in tailings at Chainage 2000 (2018-009)

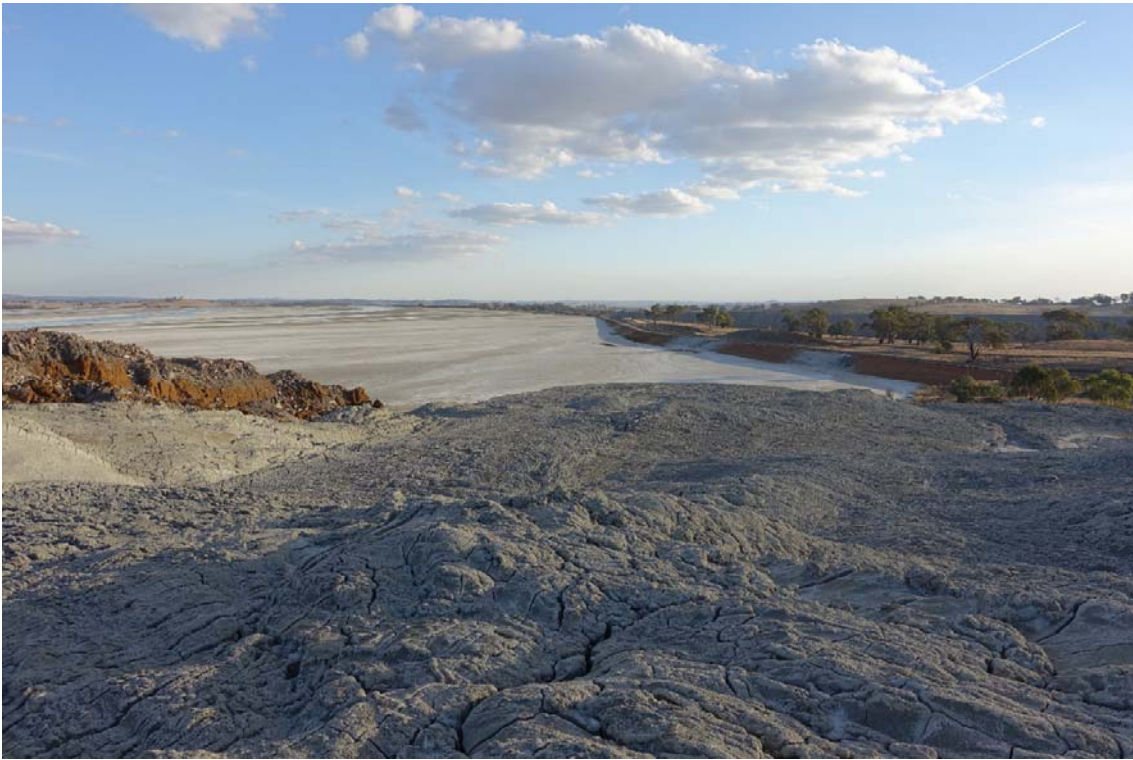
Photo B8-6: Ropey and cracked tailings from secondary runoff.

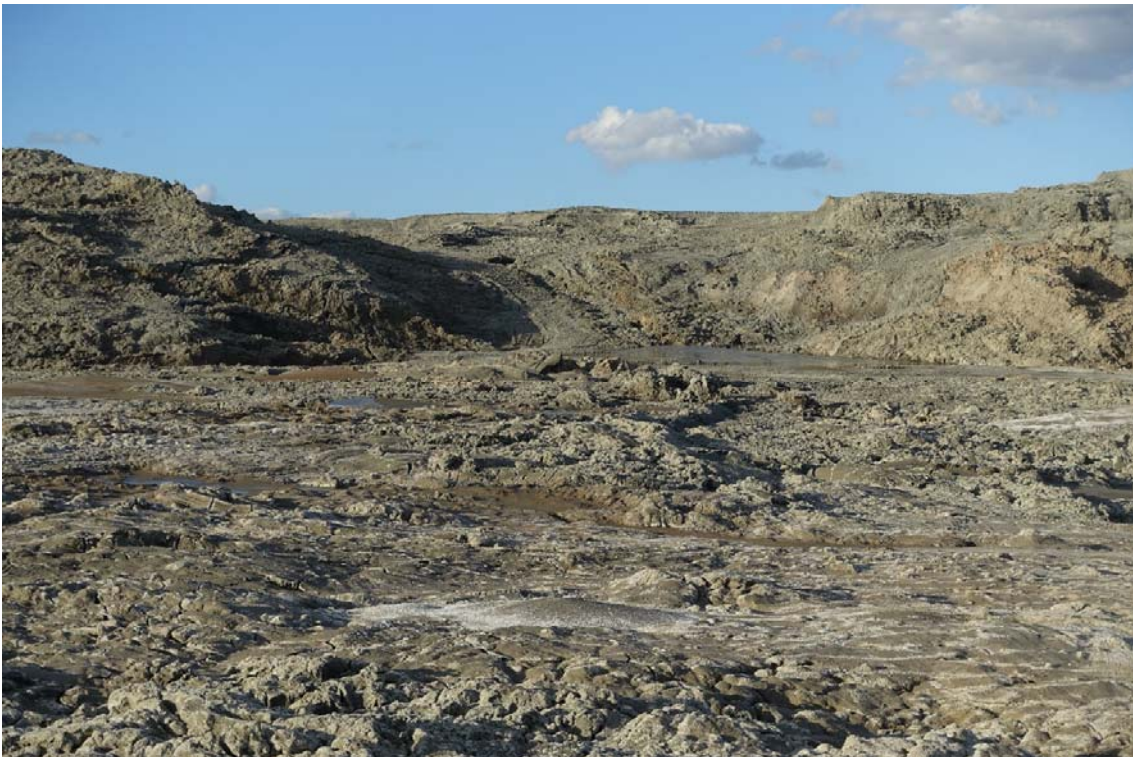
Photo B8-7: Backslope of slump with sand boils in foreground.

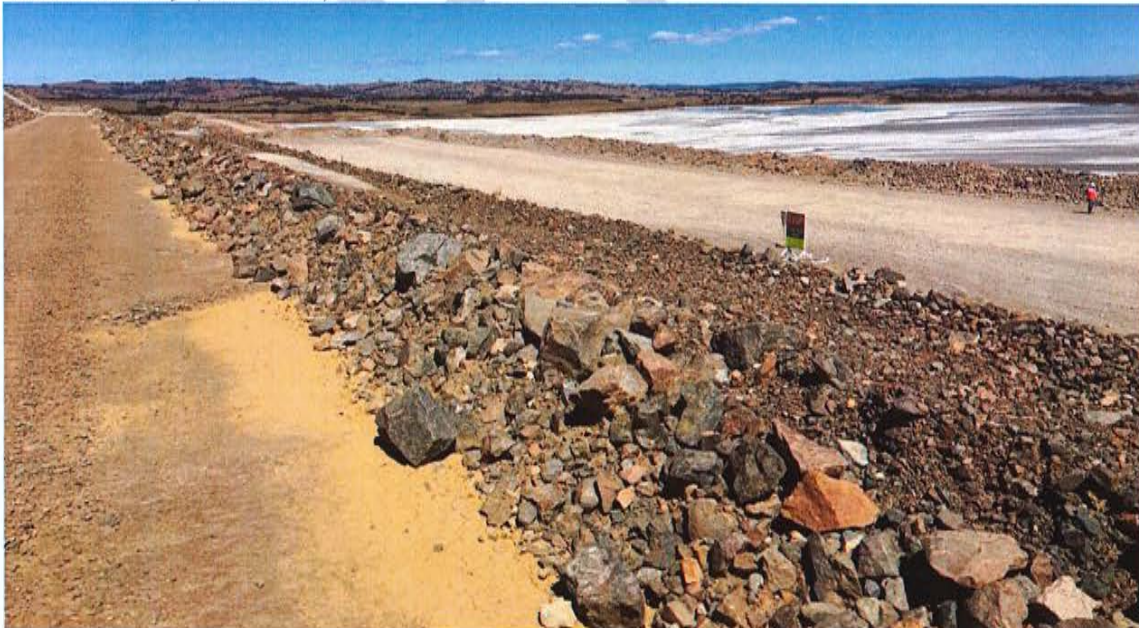
Western extent of cracking, survey marker 7, looking east along stage 9 (IMG_2533)

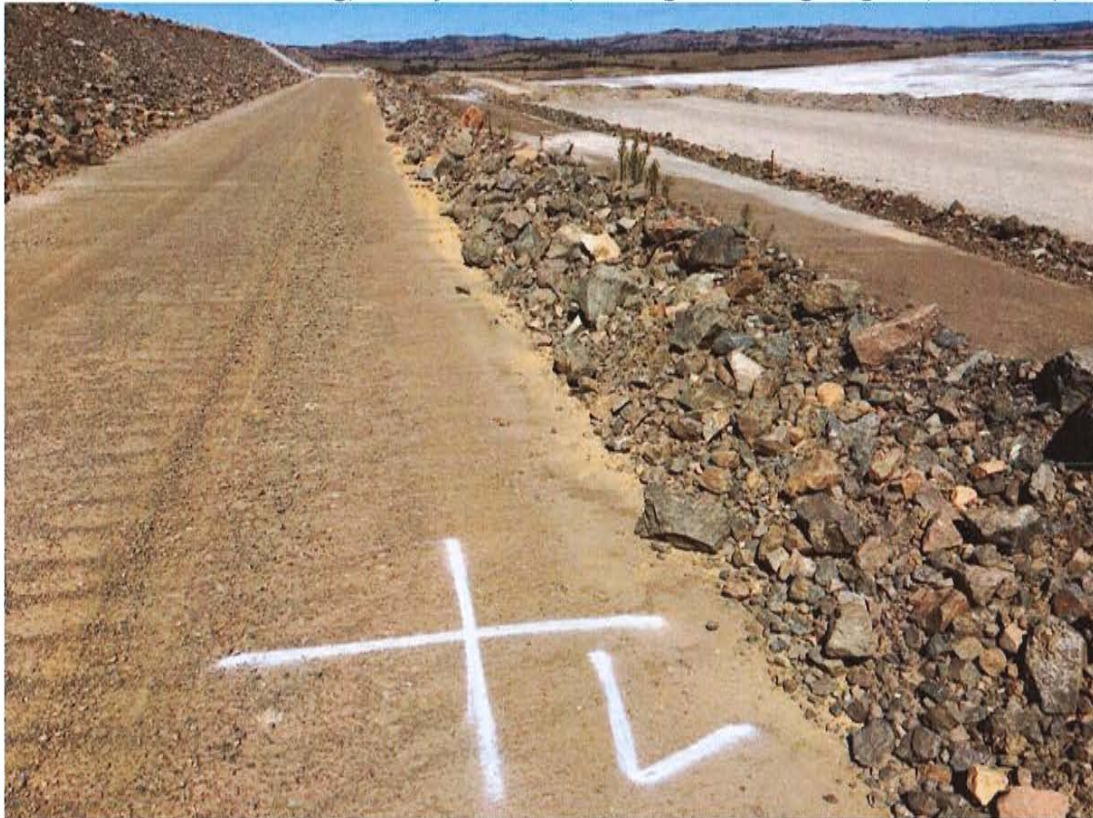
Western extent of cracking, survey marker 7, looking south (IMG_2534)

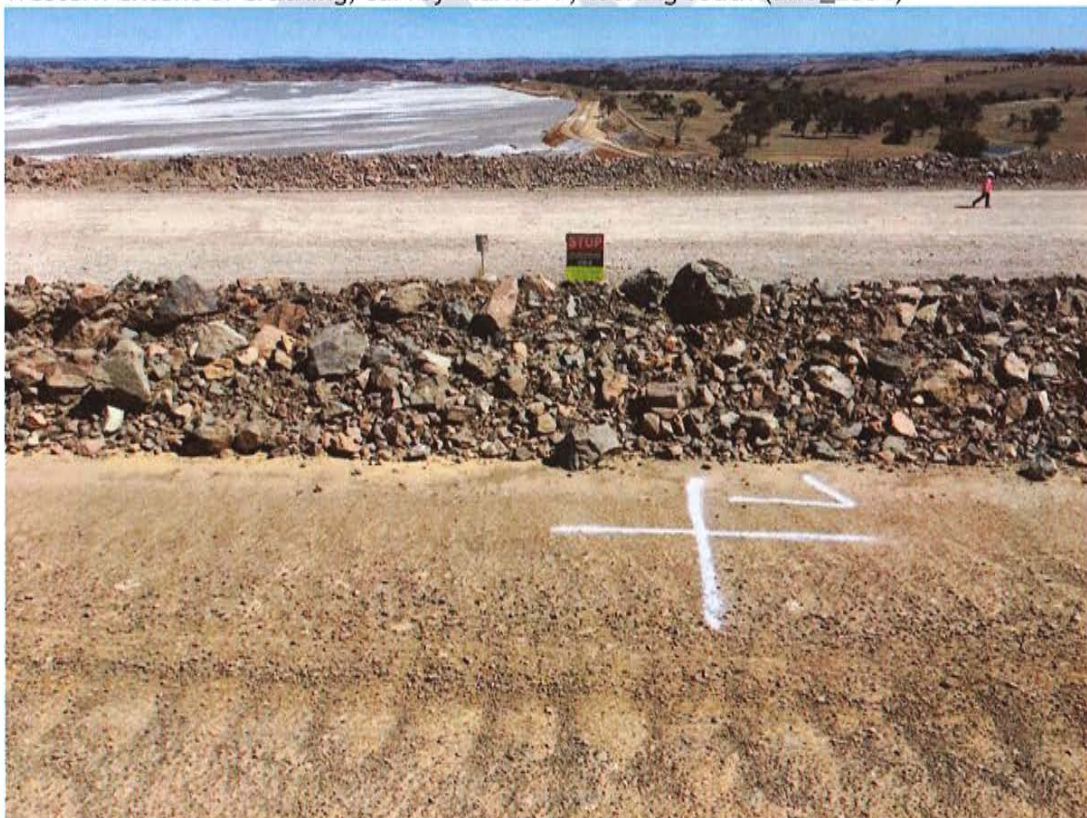
Looking from Stage 9 crest down onto Stage 8, Stage 7 and Stage 1 Buttress - this marks the western end of the cracking (IMG_2532)

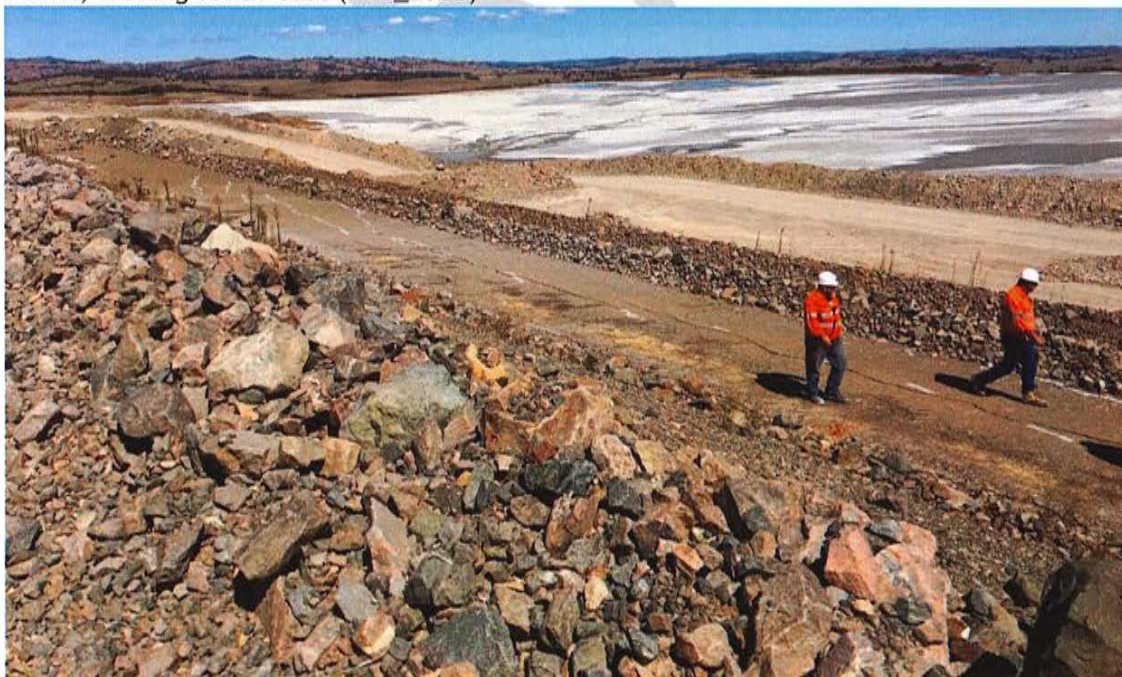
View from Stage 9 looking downstream, visible cracking on Stage 8, towards eastern end of zone of cracking (IMG_2527)

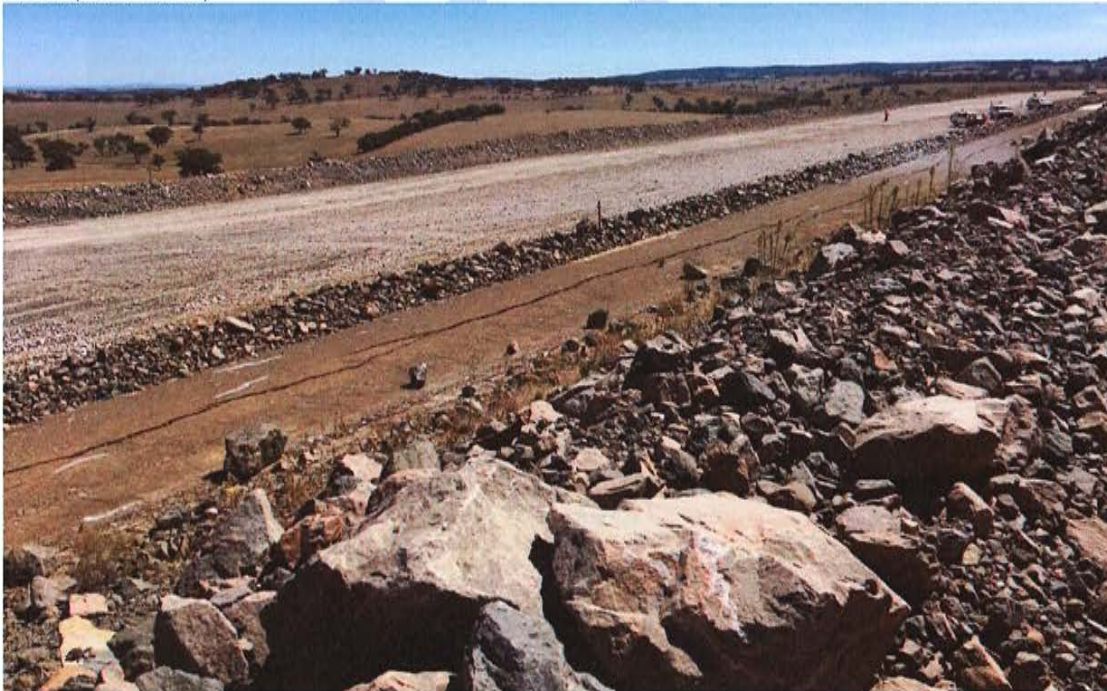
Stage 8 Crest looking East from western extent of cracking, white paint indicates cracking (IMG_2535)

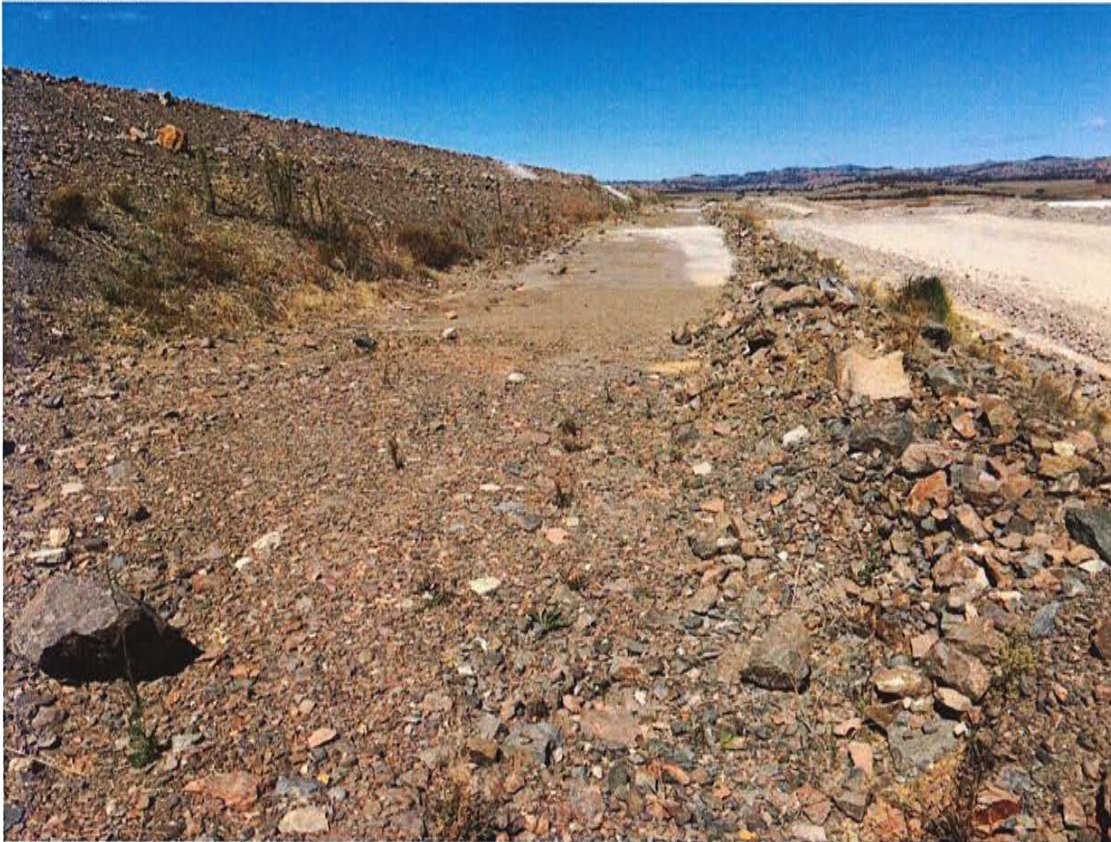
Stage 8 crest, close-up of crack opening (IMG_2526)

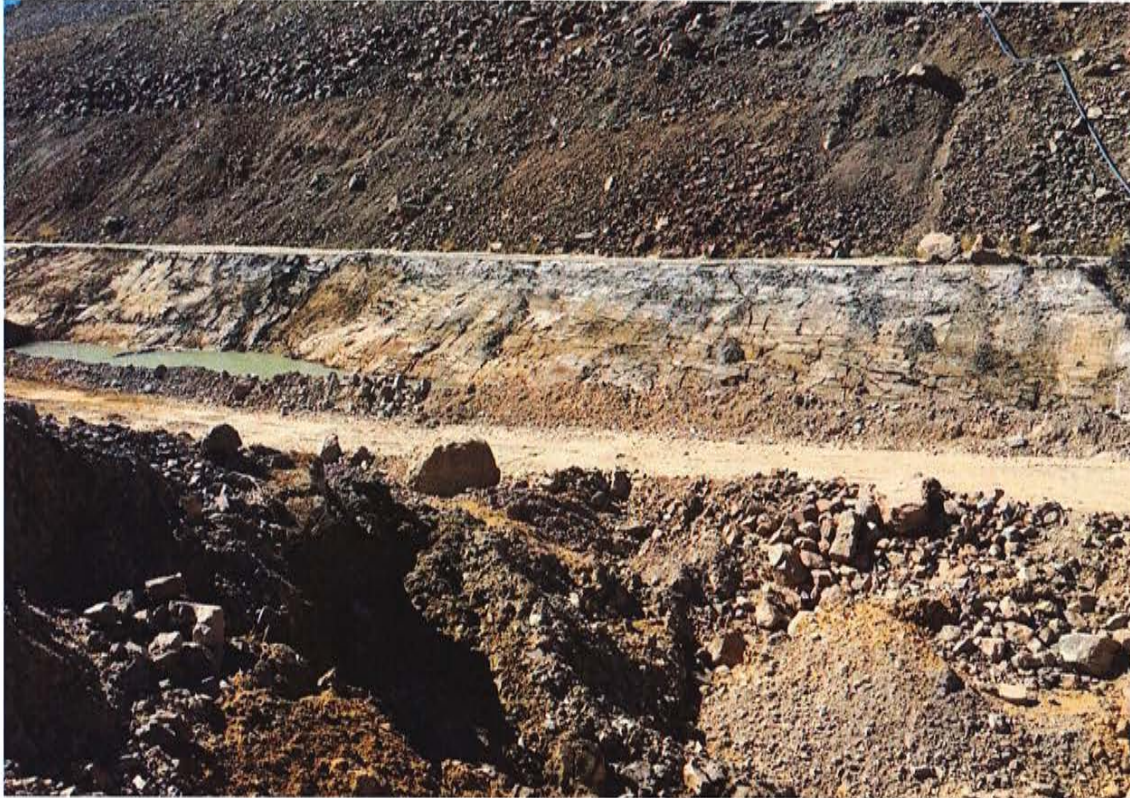
Toe area, linear cracking on exposed batter, looking westwards (IMG_2538)

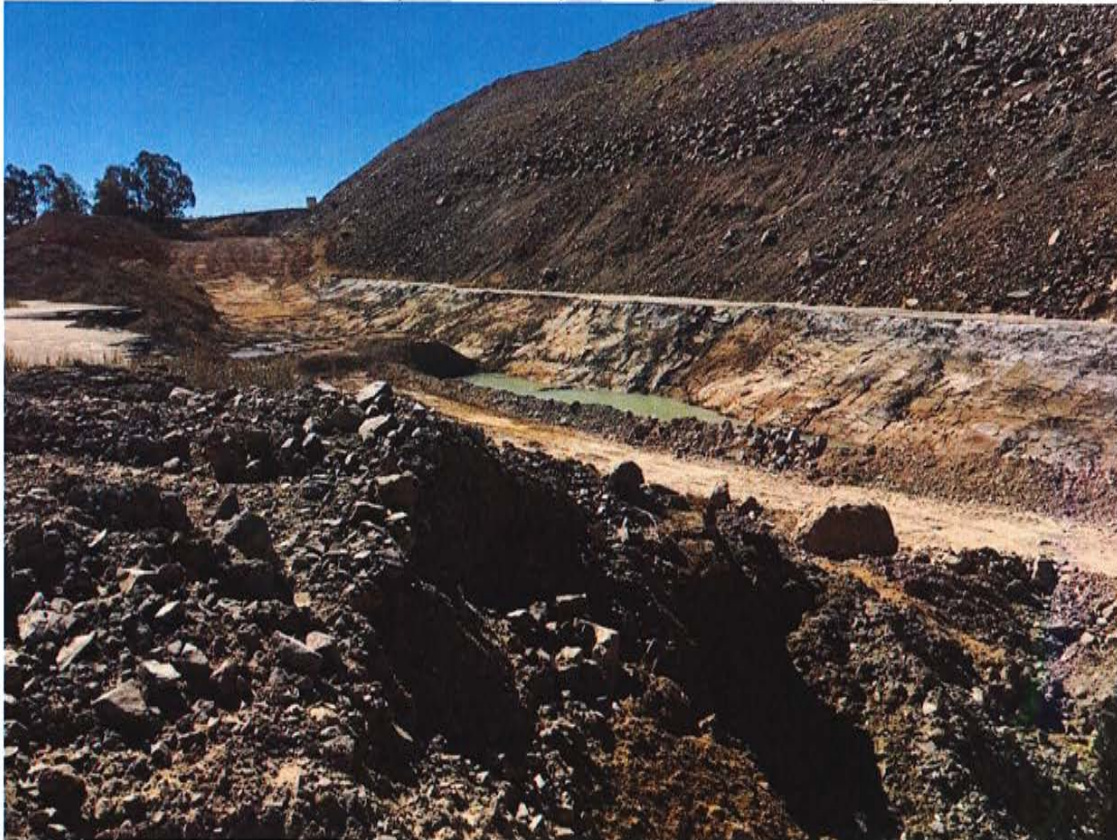
Toe area, linear cracking on exposed batter, looking NNE (IMG_2539)

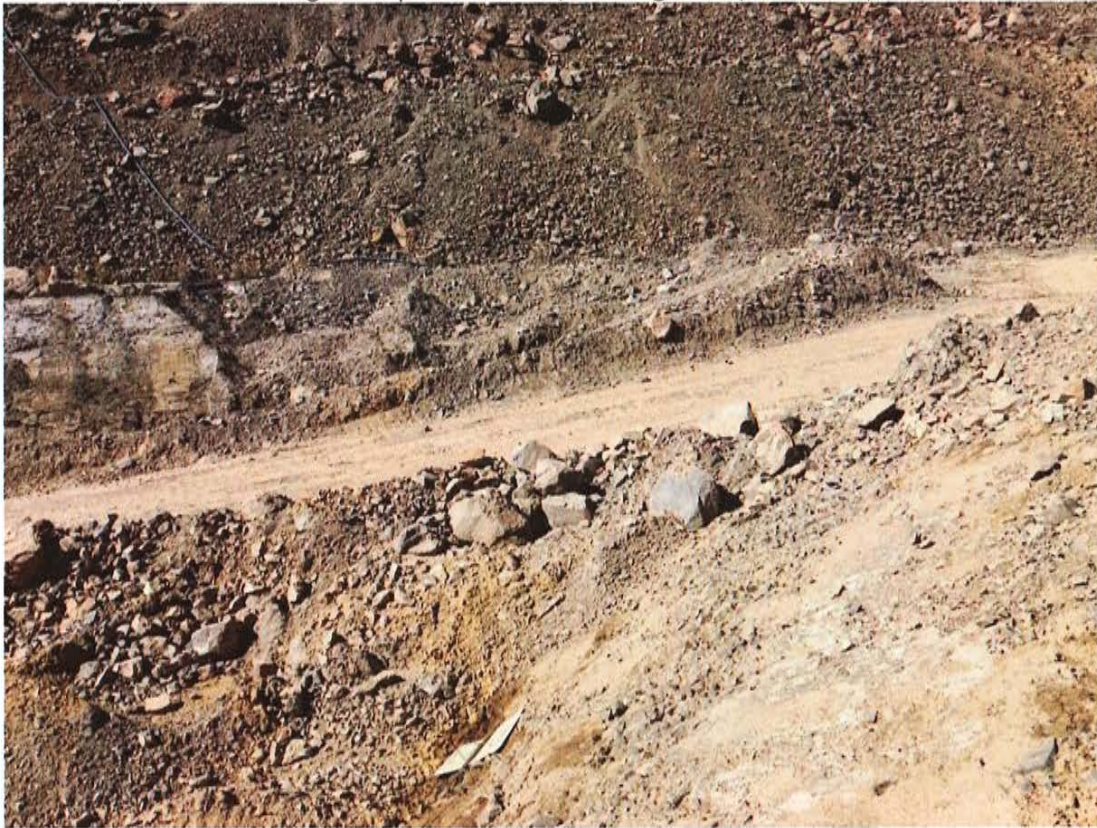
Toe area, linear cracking on access road (ground rupture), looking NE (IMG_2540)

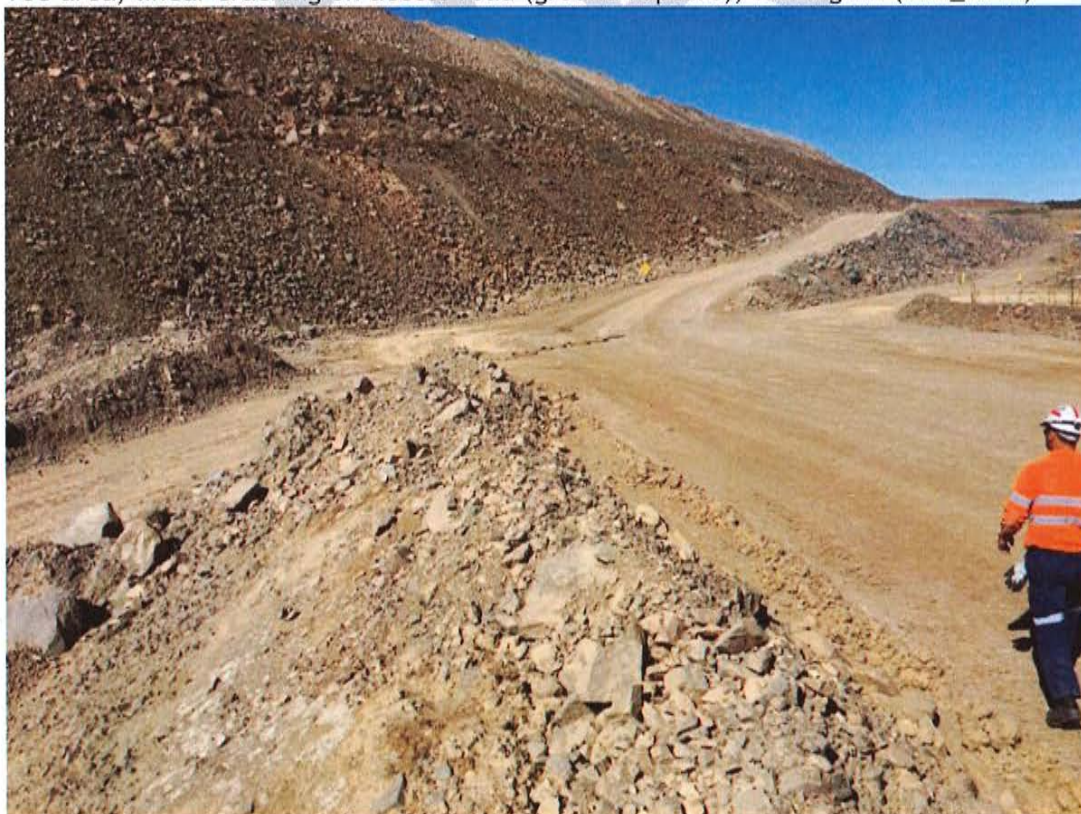
Toe area, linear cracking on access road (ground rupture), looking Northwards (IMG_2541)

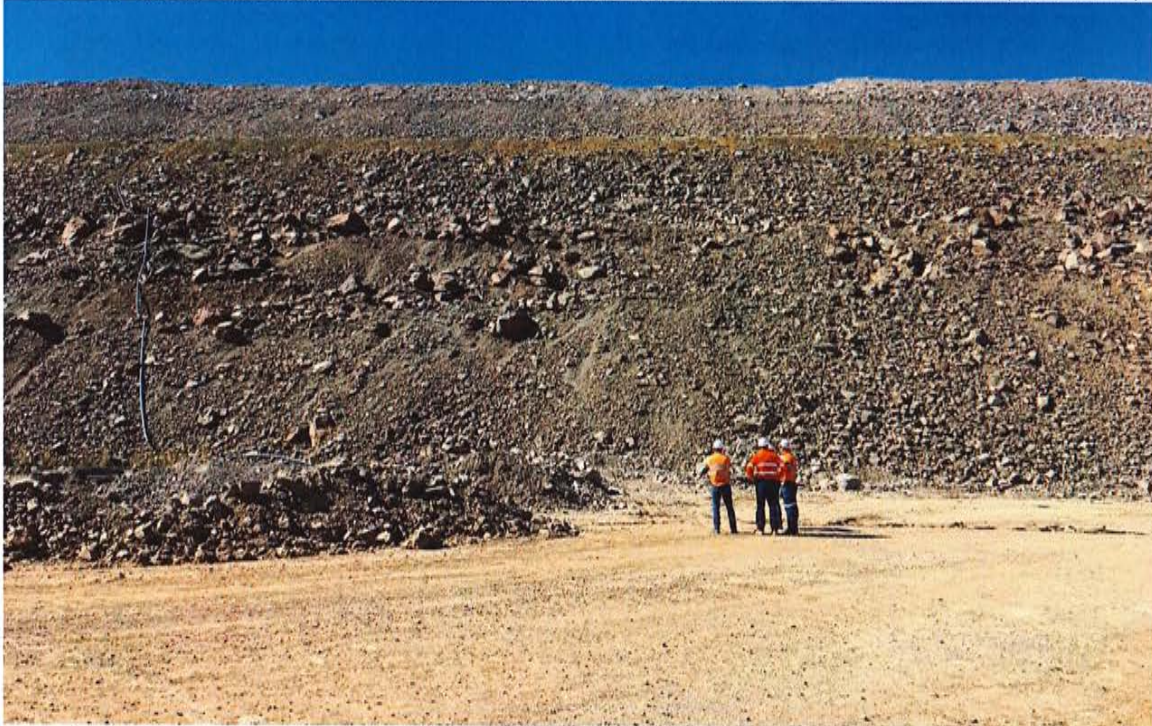
Toe area, linear cracking on access road (ground rupture), looking North-easterly (IMG_2542)

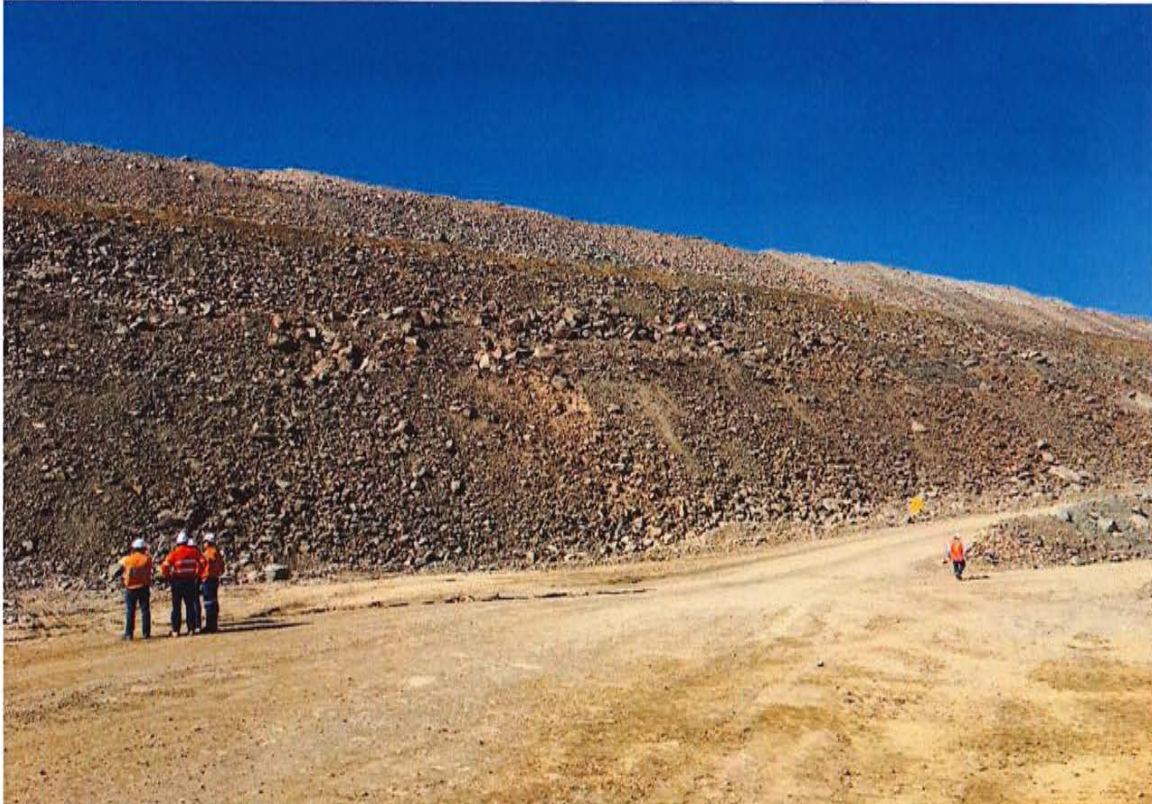
Toe area, linear cracking on access road (ground rupture), looking North-easterly (IMG_2543)
