Appendix B: History of NTSF

In the late afternoon of Friday 9 March 2018, following the identification of cracks on the dam crest earlier in the day, a slump occurred on the western side of the southern embankment of the NTSF.

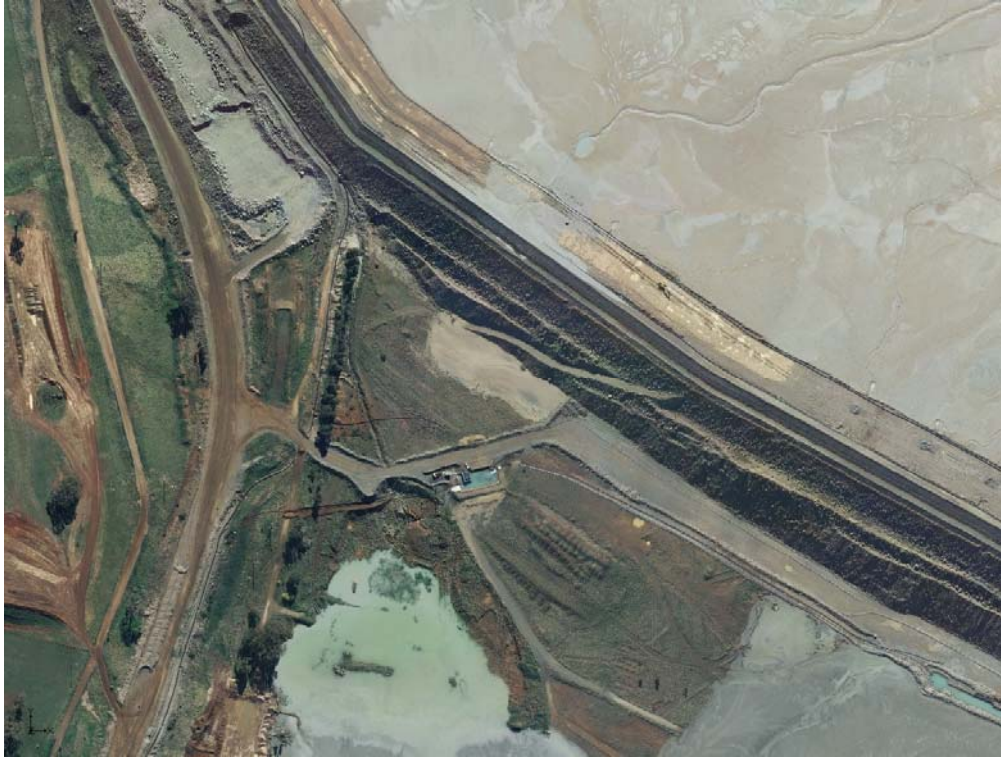
Photo B2-3: Downstream of NTSF embankment (2010) (2010-001)

- Tailings have overflowed the Stage 4 crest (reported in Stage 5 Construction Report) (2011-001).
- The downstream berm across the upper reaches of the STSF has been completed.

- Tailings are starting to accumulate in a depression at the western end of the berm. The tailings originate from a STSF tailings pipeline break pressure overflow.

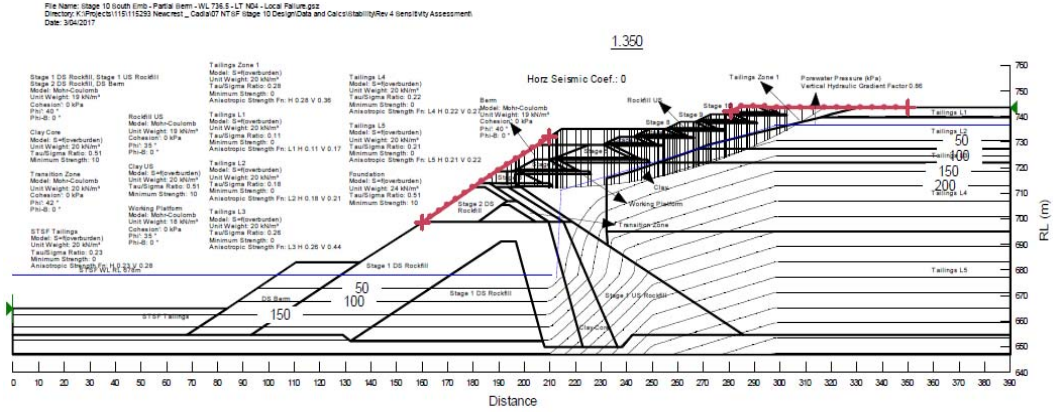
Figure B2-7: Stage 1 Butress Static FOS for Southern Embankment (2017-001).

The Stage 1 Buttress was designed by ATCW to increase the static short term (undrained) FOS of a potential slip surface extending through the upstream raises as shown in Figure B2-7, while the Stage 2 Buttress was designed to increase the static long term (drained) FOS of a potential slip surface extending through the foundations as shown in Figure B2-8.

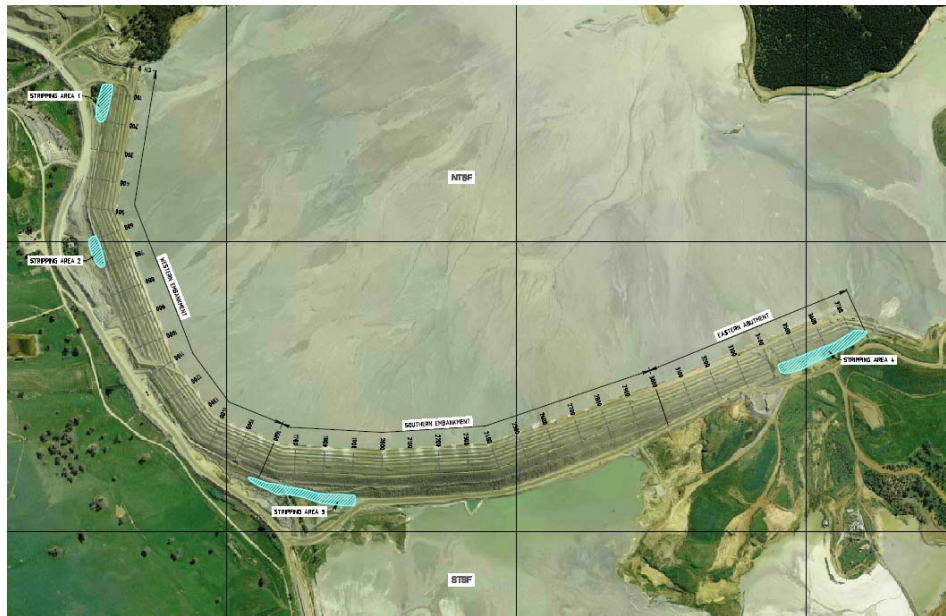
Photo B2-6: ATCW Stage 2 Buttress foundation stripping recommendations (2017-002)

In April 2017 ATCW (2017-002) prepared a memorandum identifying the stripping required at the toe of the NTSF required for the Stage 2 Buttress placement. This advice was based on the excavation of nine (9) test pits which identified four areas requiring stripping, the locations of which are shown on Photo B2-6.

Of particular interest to the NTSF Embankment Failure investigation is Stripping Area 3, where in excess of 4m of tailings had accumulated in a depression (previously noted in Section B2.5). The extent of the tailings can be more clearly seen in Photo B2-7 after the depression had been partially excavated to make more room for additional tailings overflow.

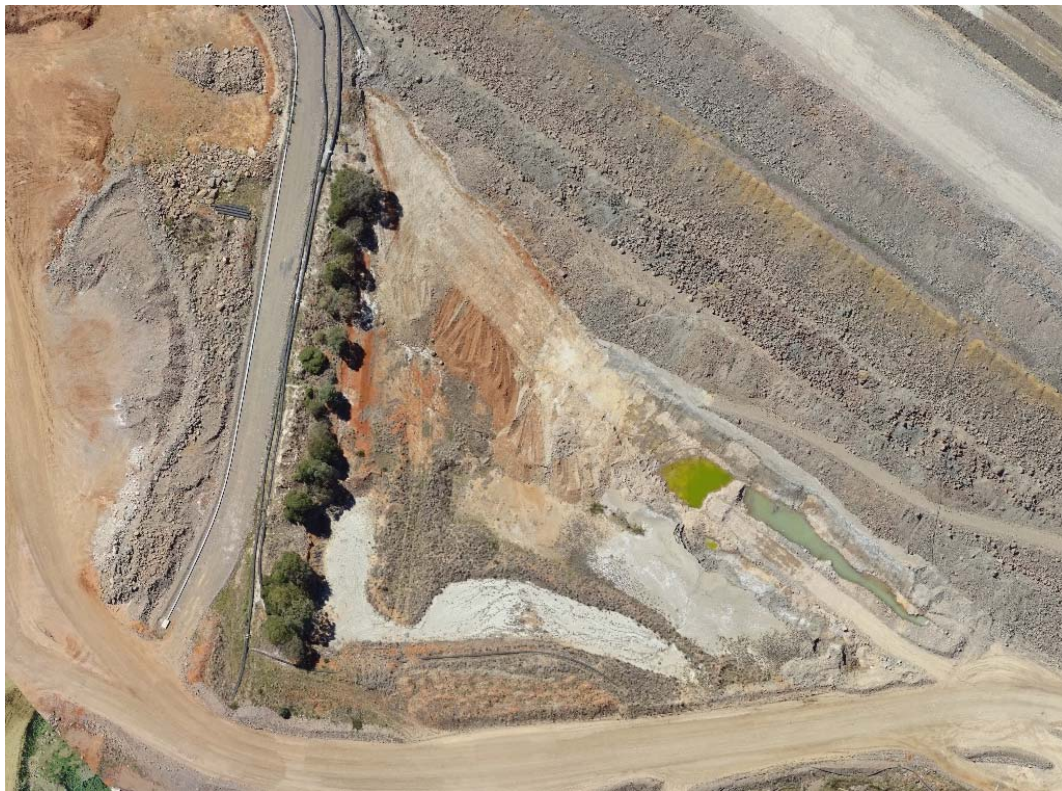
Photo B2-10: Toe excavation on 9th March 2018 (2018-004)

Apart from further removal of tailings and residual soils to the west, and the accumulation of a small amount of seepage, the excavation remained in this condition, with an estimated base at RL676, until the time of failure on 9th March 2018 (Photo B2-10).

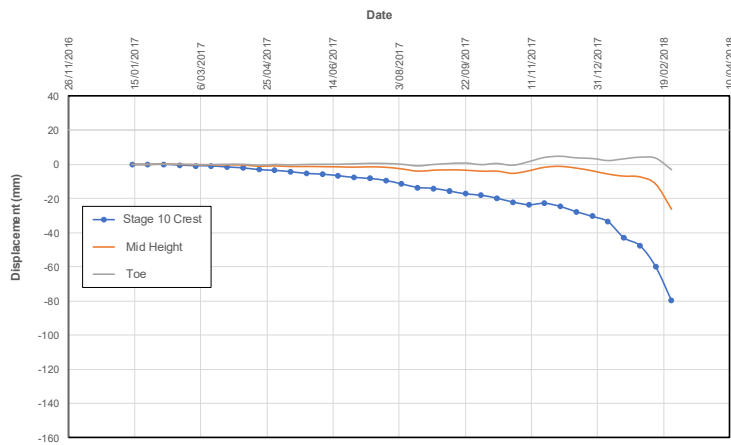
Figure B5-7: InSAR surface movement measurements at Ch 2000

InSAR surface movement time series taken at the crest, mid height and toe in the vicinity of the slump (Ch2000) are presented in Figure B5-7. Data at the crest shows an increased rate of movement from 8th January 2018. A small increase in the rate of movement was observed at mid height, while none was apparent at the toe. The exception to this is data from 25th February 2018, which presents as a down kick on most, if not all data across the Cadia area. This regional down kick was attributed to abnormal atmospheric conditions on the particular day and was subsequently removed by reprocessing the data based on reference point location nearby.

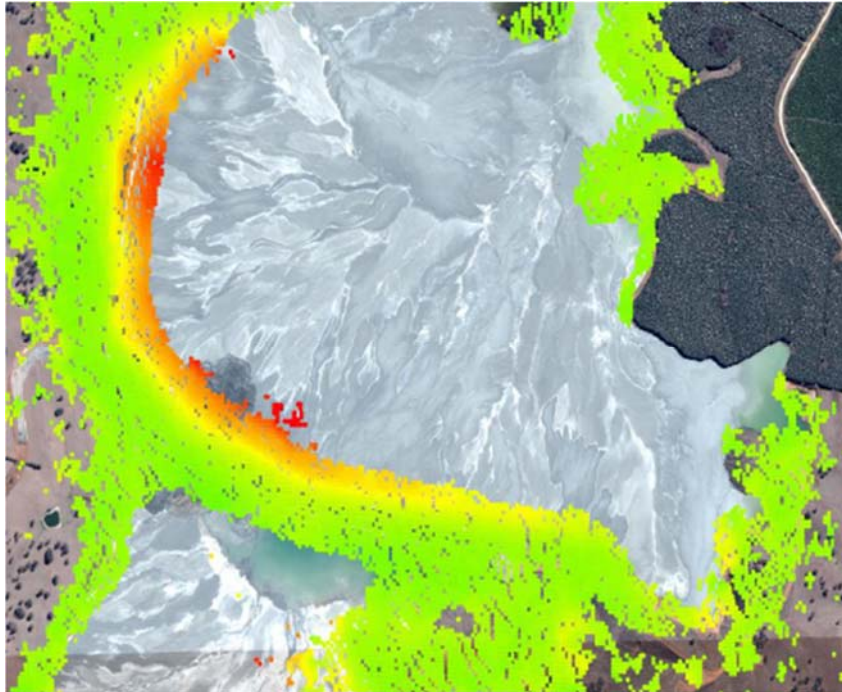
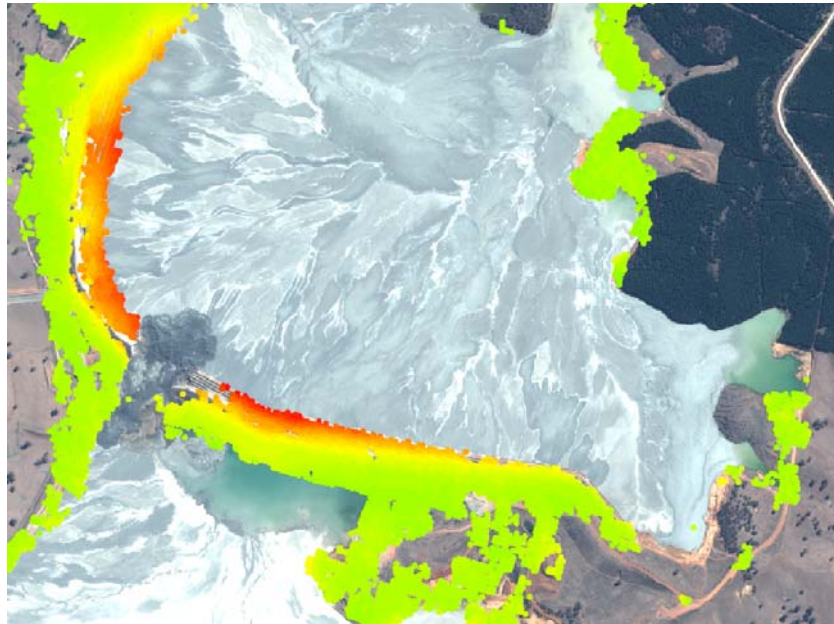
An average velocity map of the NTSF embankment, showing movement velocity in millimeters per year, was an output from the data processing by Airbus DS. An average velocity map provided for the period 13th January 2017 and 25th February 2018 is shown as Figure B5-8 while one for the period 13th January 2017 and 5th September 2018 is shown as Figure B5-9. Red areas on these maps show a relatively faster rate of movement.

A comparison of Figure B5-8 and Figure B5-9 indicates that the increased rate of movement (red area) was not confined to the slump but continued after the event and moved to the east.

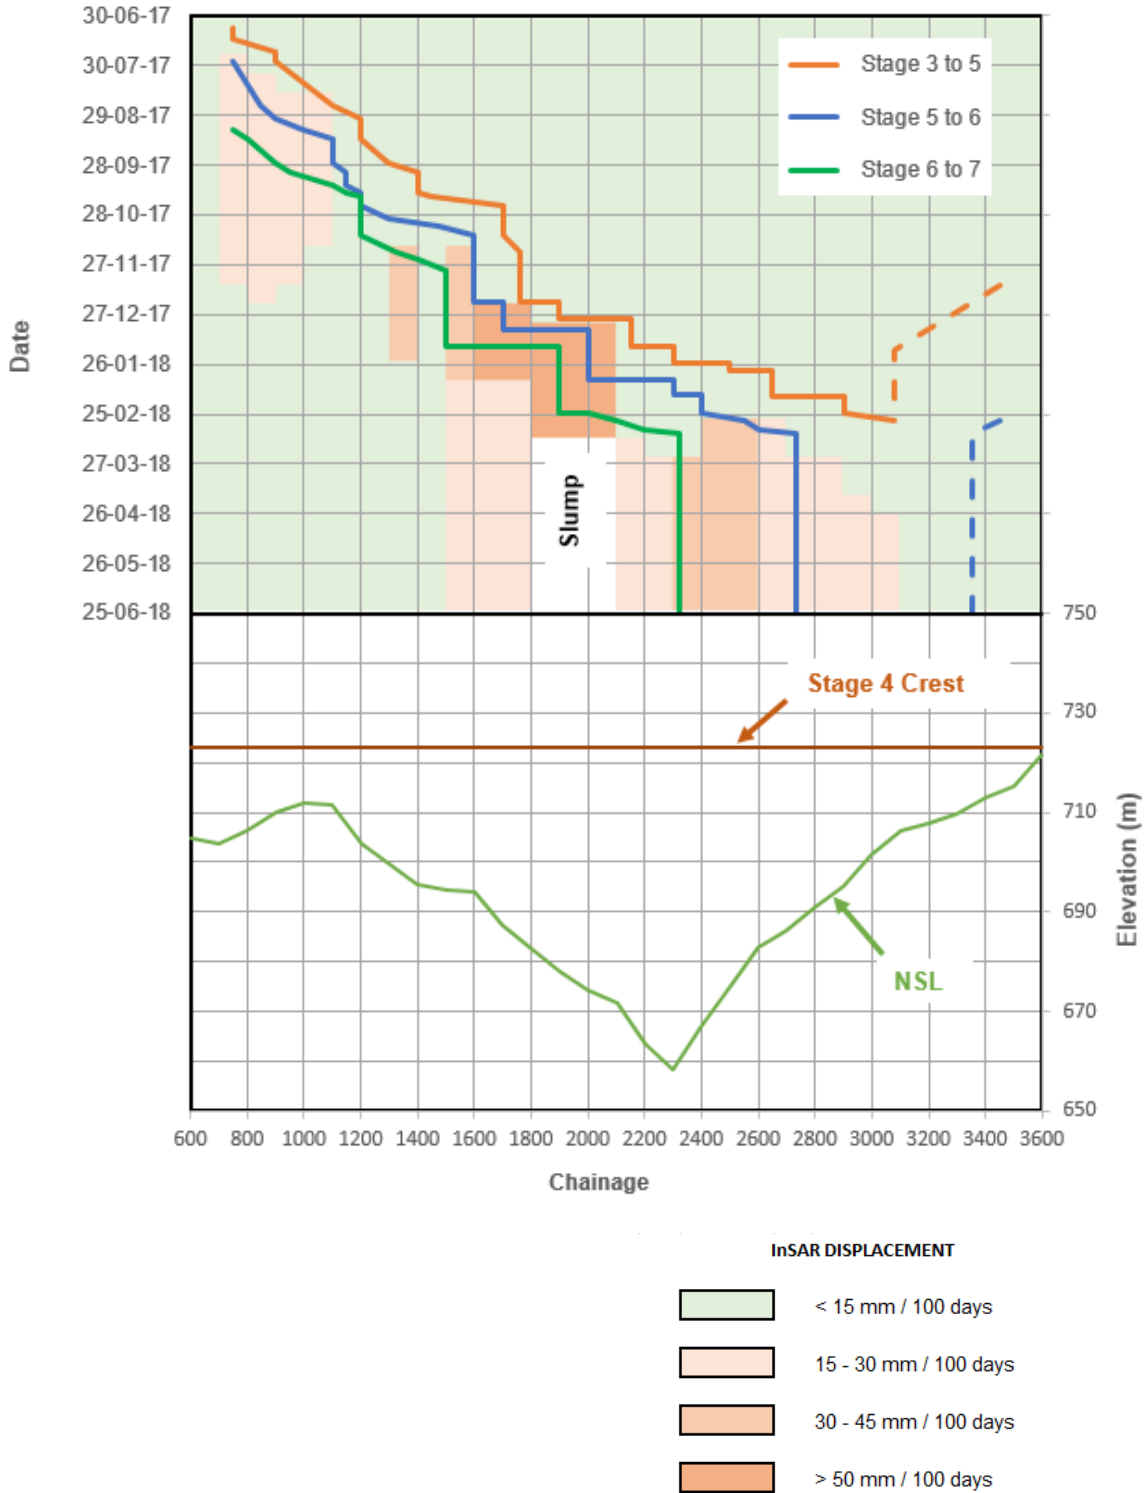
Figure B5-11: InSAR rate of displacement related to Buttress 1 construction progress

Figure B5-11 shows a close relationship between the Buttress 1 construction and an increased rate of displacement measured using the InSAR time series. In addition, where the depth of tailings below the Stage 5 embankment (Stage 4 embankment crest) is less than ~15m the increase in the rate of displacement is either negligible or of limited duration.

Although there is a close relationship between an increase in the rate of displacement measured by InSAR and the Buttress 1 construction together with the depth of tailings beneath Buttress 1, the rate of displacement measured in the immediate vicinity of the slump after the Buttress 1 construction is larger than that recorded elsewhere on the NTSF, including where the tailings are significantly deeper.

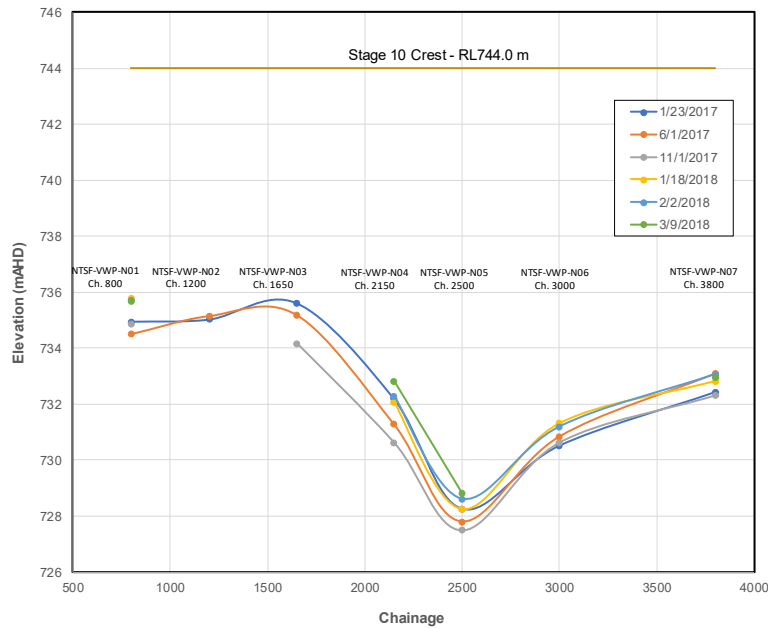
Figure B5-13: Longitudinal profile of piezometric surface with time

The deeper groundwater surface in the vicinity of Ch2500 can also be seen in a longitudinal profile of the piezometric surface (Figure B5-13). This and the pressure gradient less than hydrostatic can most likely be attributed to downward drainage towards the Stage 1 underdrainage system, installed between Ch2300 and 2600 to assist in the consolidation of the tailings.

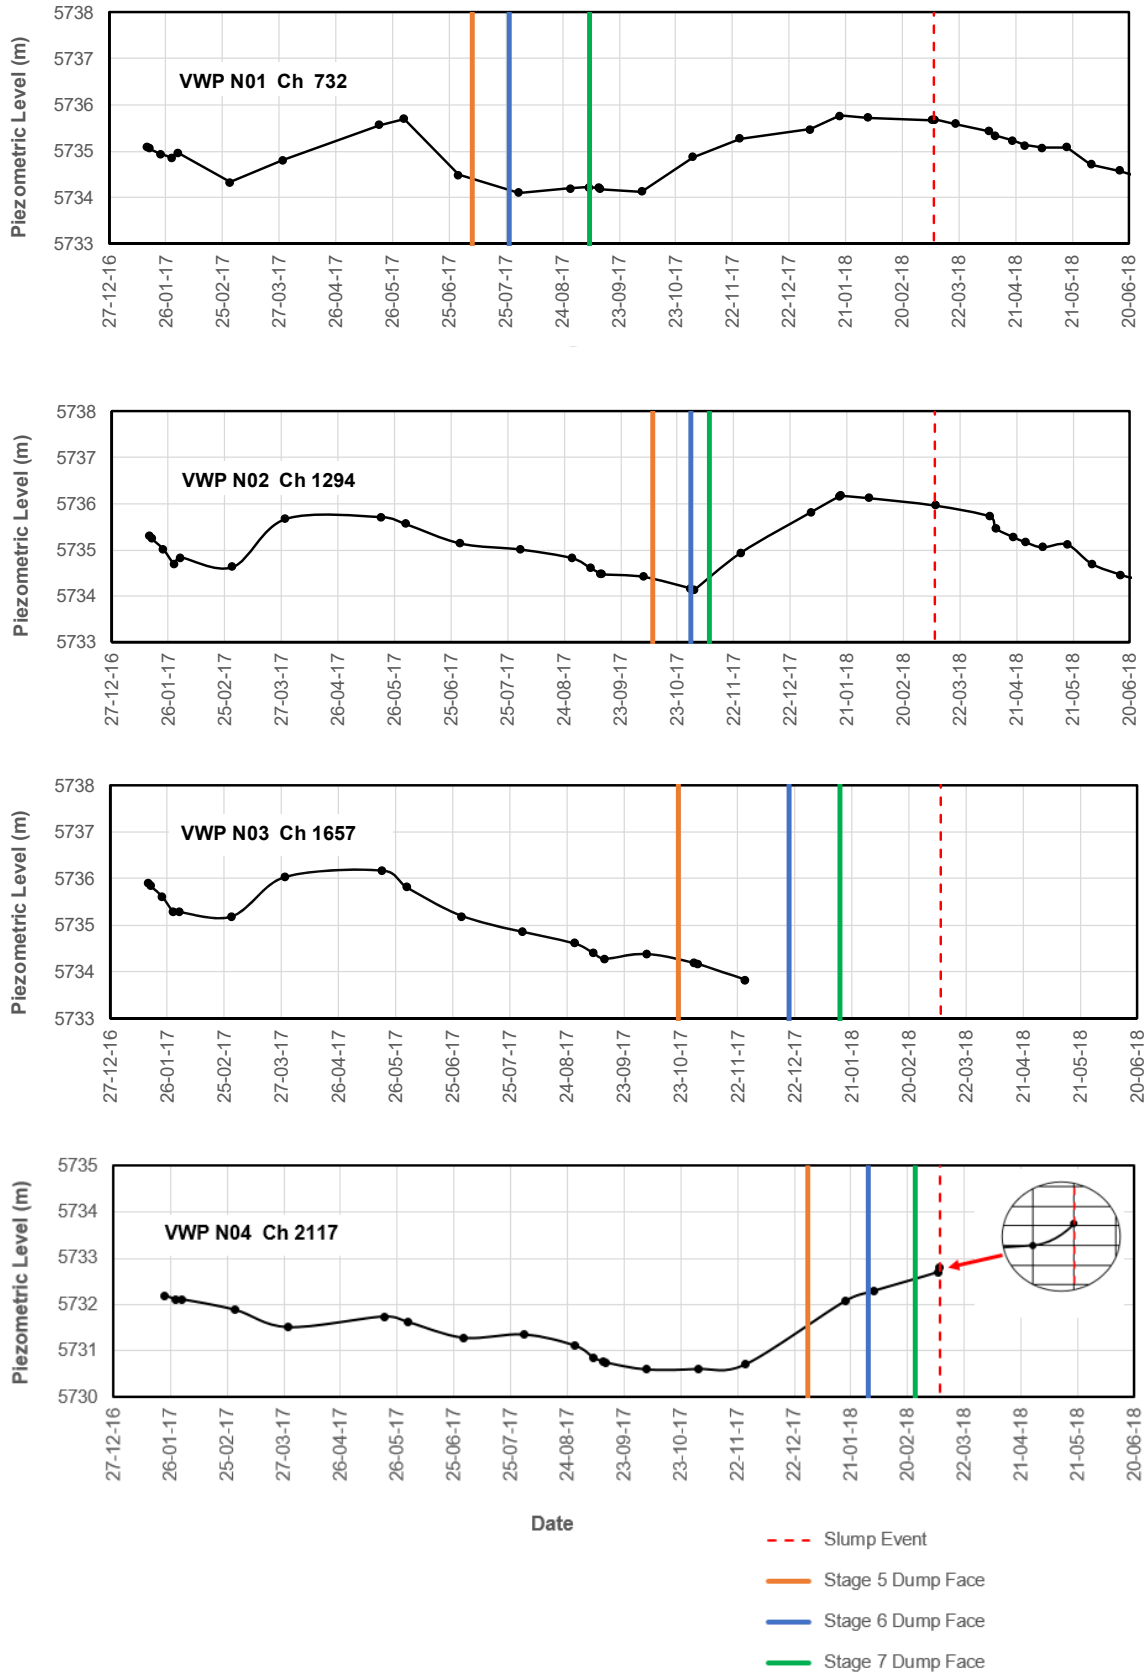
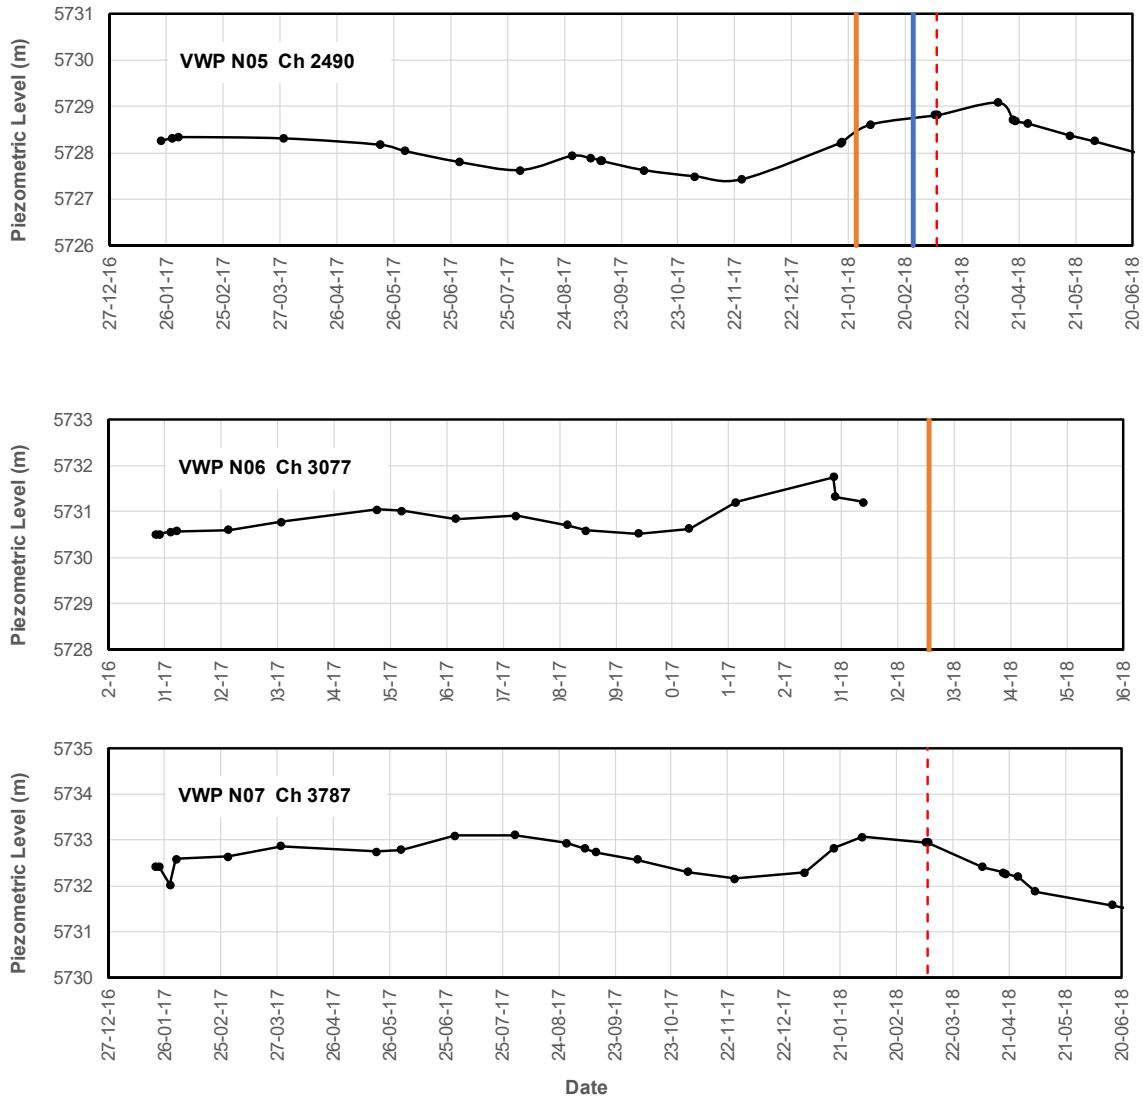
Figure B5-14: VWP piezometer measurements showing stages of Buttress 1 construction

Piezometer measurements for VWP installed in January 2017 (VWP N01 to N07) are provided in Figure B5-14. Also shown on the piezometer records is the progress of the Stage 5, 6 and 7 of the Buttress 1 construction (refer to Figure B5-11) and the timing of the slump event. Although the NTSF Stage 10 raise was constructed during 2017, piezometers surprisingly show a static or declining trend until the commencement of the Buttress 1 construction when a noticeable increase in level was observed around the time of or shortly after the commencement of the construction. The exception to this is VWP N03 and N06 which ceased to operate prior to the buttress construction and N07 which was located beyond the buttress construction.

Also shown on Figure B5-14 is a small (0.11m) rise in piezometer VWP-N04 on the day of the slump.

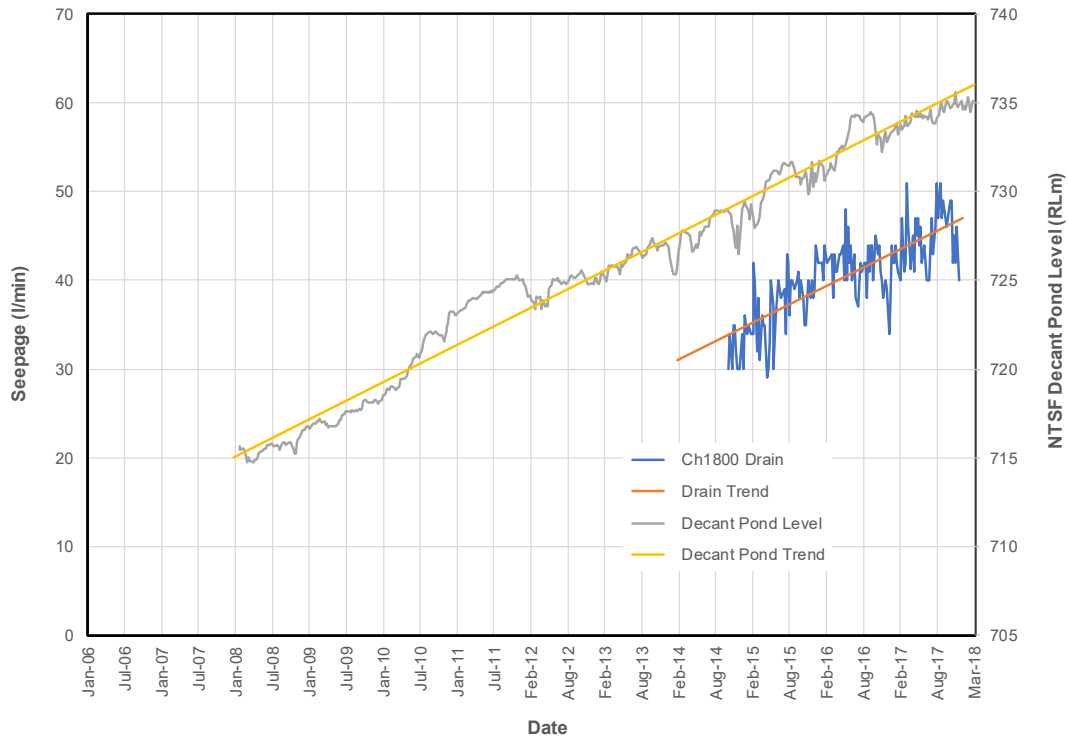
Figure B5-15: Ch1800 drain flow and NTSF decant pond level

The Stage 3 drains have remained dry, except for the western drain (Chainage 1800). Although seepage from this drain was noted for some time, it was not until a pipe (to toe of the NTSF) was attached to the drain, that accurate measurements of drain flow were made. Drain flow measurements between early 2015 and February 2018 (excluding a couple of outliers) are plotted on Figure B5-15 and range between 30 and 50 litres/minute. A trend line through this data

indicates that the flow possibly commenced in mid-2006 and prior to the NTSF Embankment failure a 10 l/min increase in the flow was observed for each 5m rise in the decant pond level. The seepage data file is provided in Appendix K (2018-030).

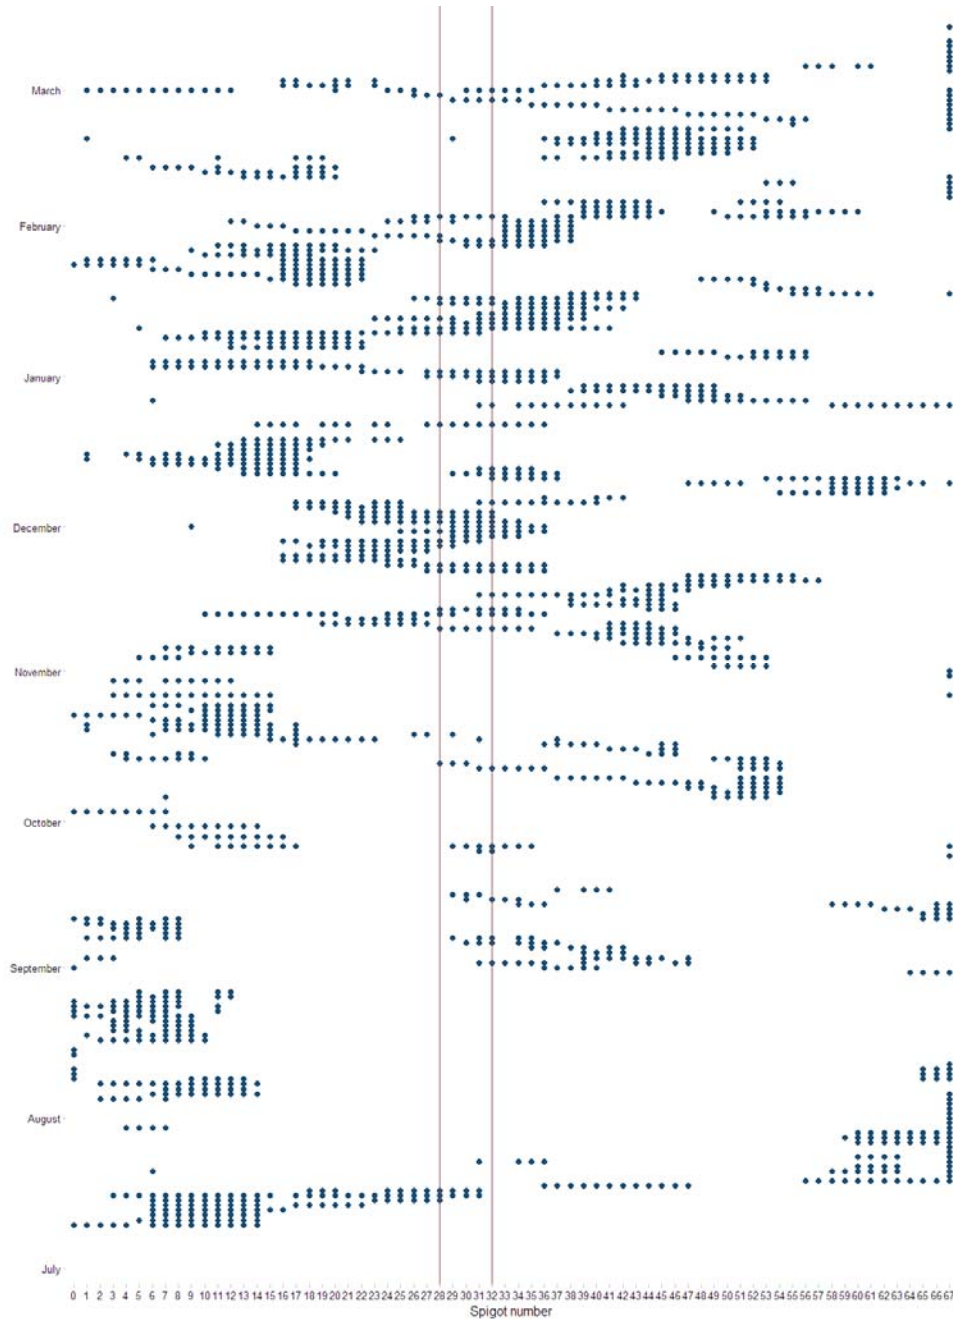
Figure B7-3: NTSF spigot opening sequence between July 2017 and 9 March 2018

The NTSF spigot opening sequence between July 2017 and 9 March 2018 is shown as Figure B7-3, highlights the sweeping nature of the tailings discharge. In Figure B7-3 dots indicate open spigots. The NTSF embankment failure is located between Spigots 28 and 32.

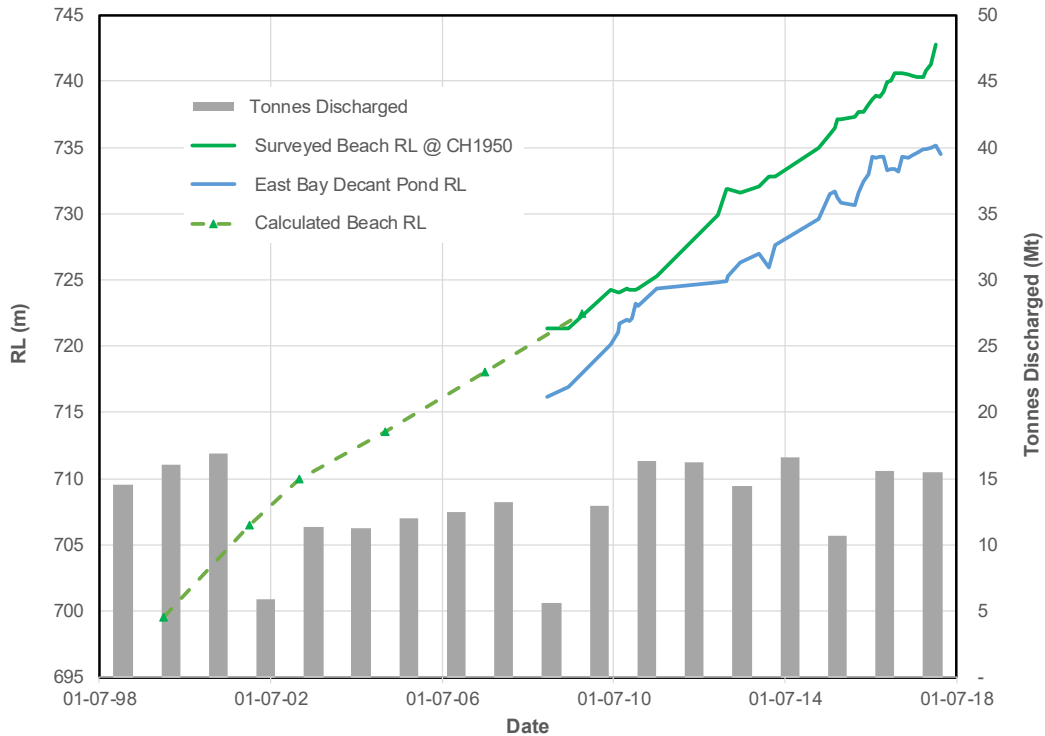
Figure B7-4: Tailings beach and decant pond levels

- Good agreement between the modelled and surveyed levels;
- A tailings rate of rise of ~1.9m /year prior to 2010;
- A tailings rate of rise of ~2.4m/year after 2010; and
- An average beach slope of ~ 0.3%.

The increased rate of rise after 2010 corresponds to an increase in the tailings discharged to the NTSF from 11.54 Mtpa to 14.83Mtpa.

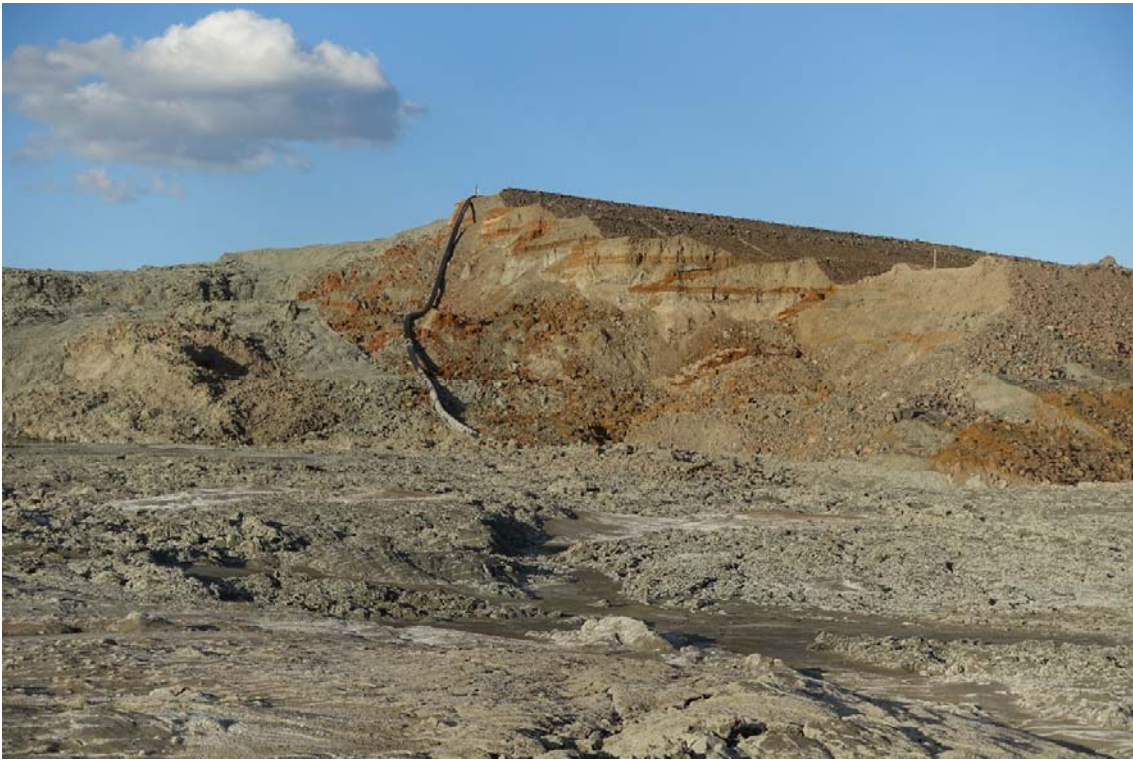
Photo B8-8: Left abutment showing well-constructed and clear embankment zoning.

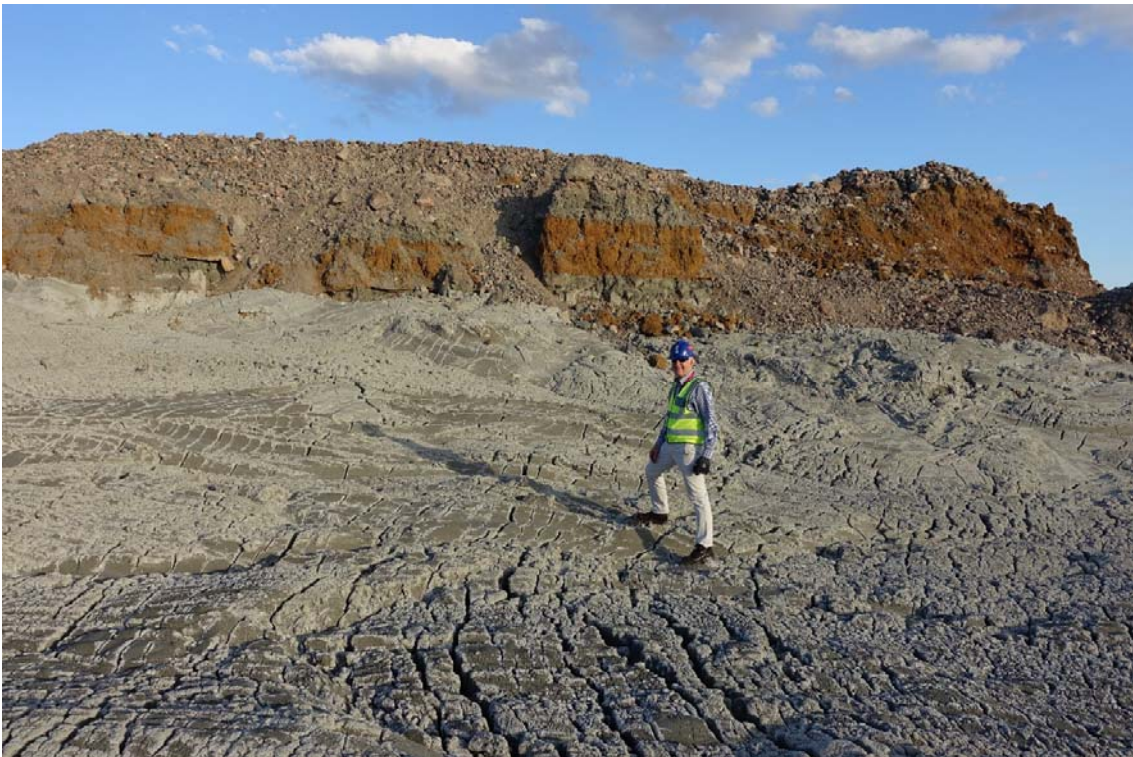
Photo B8-9: Eastern side of slump showing basal clay layer to Stage 4 or above.

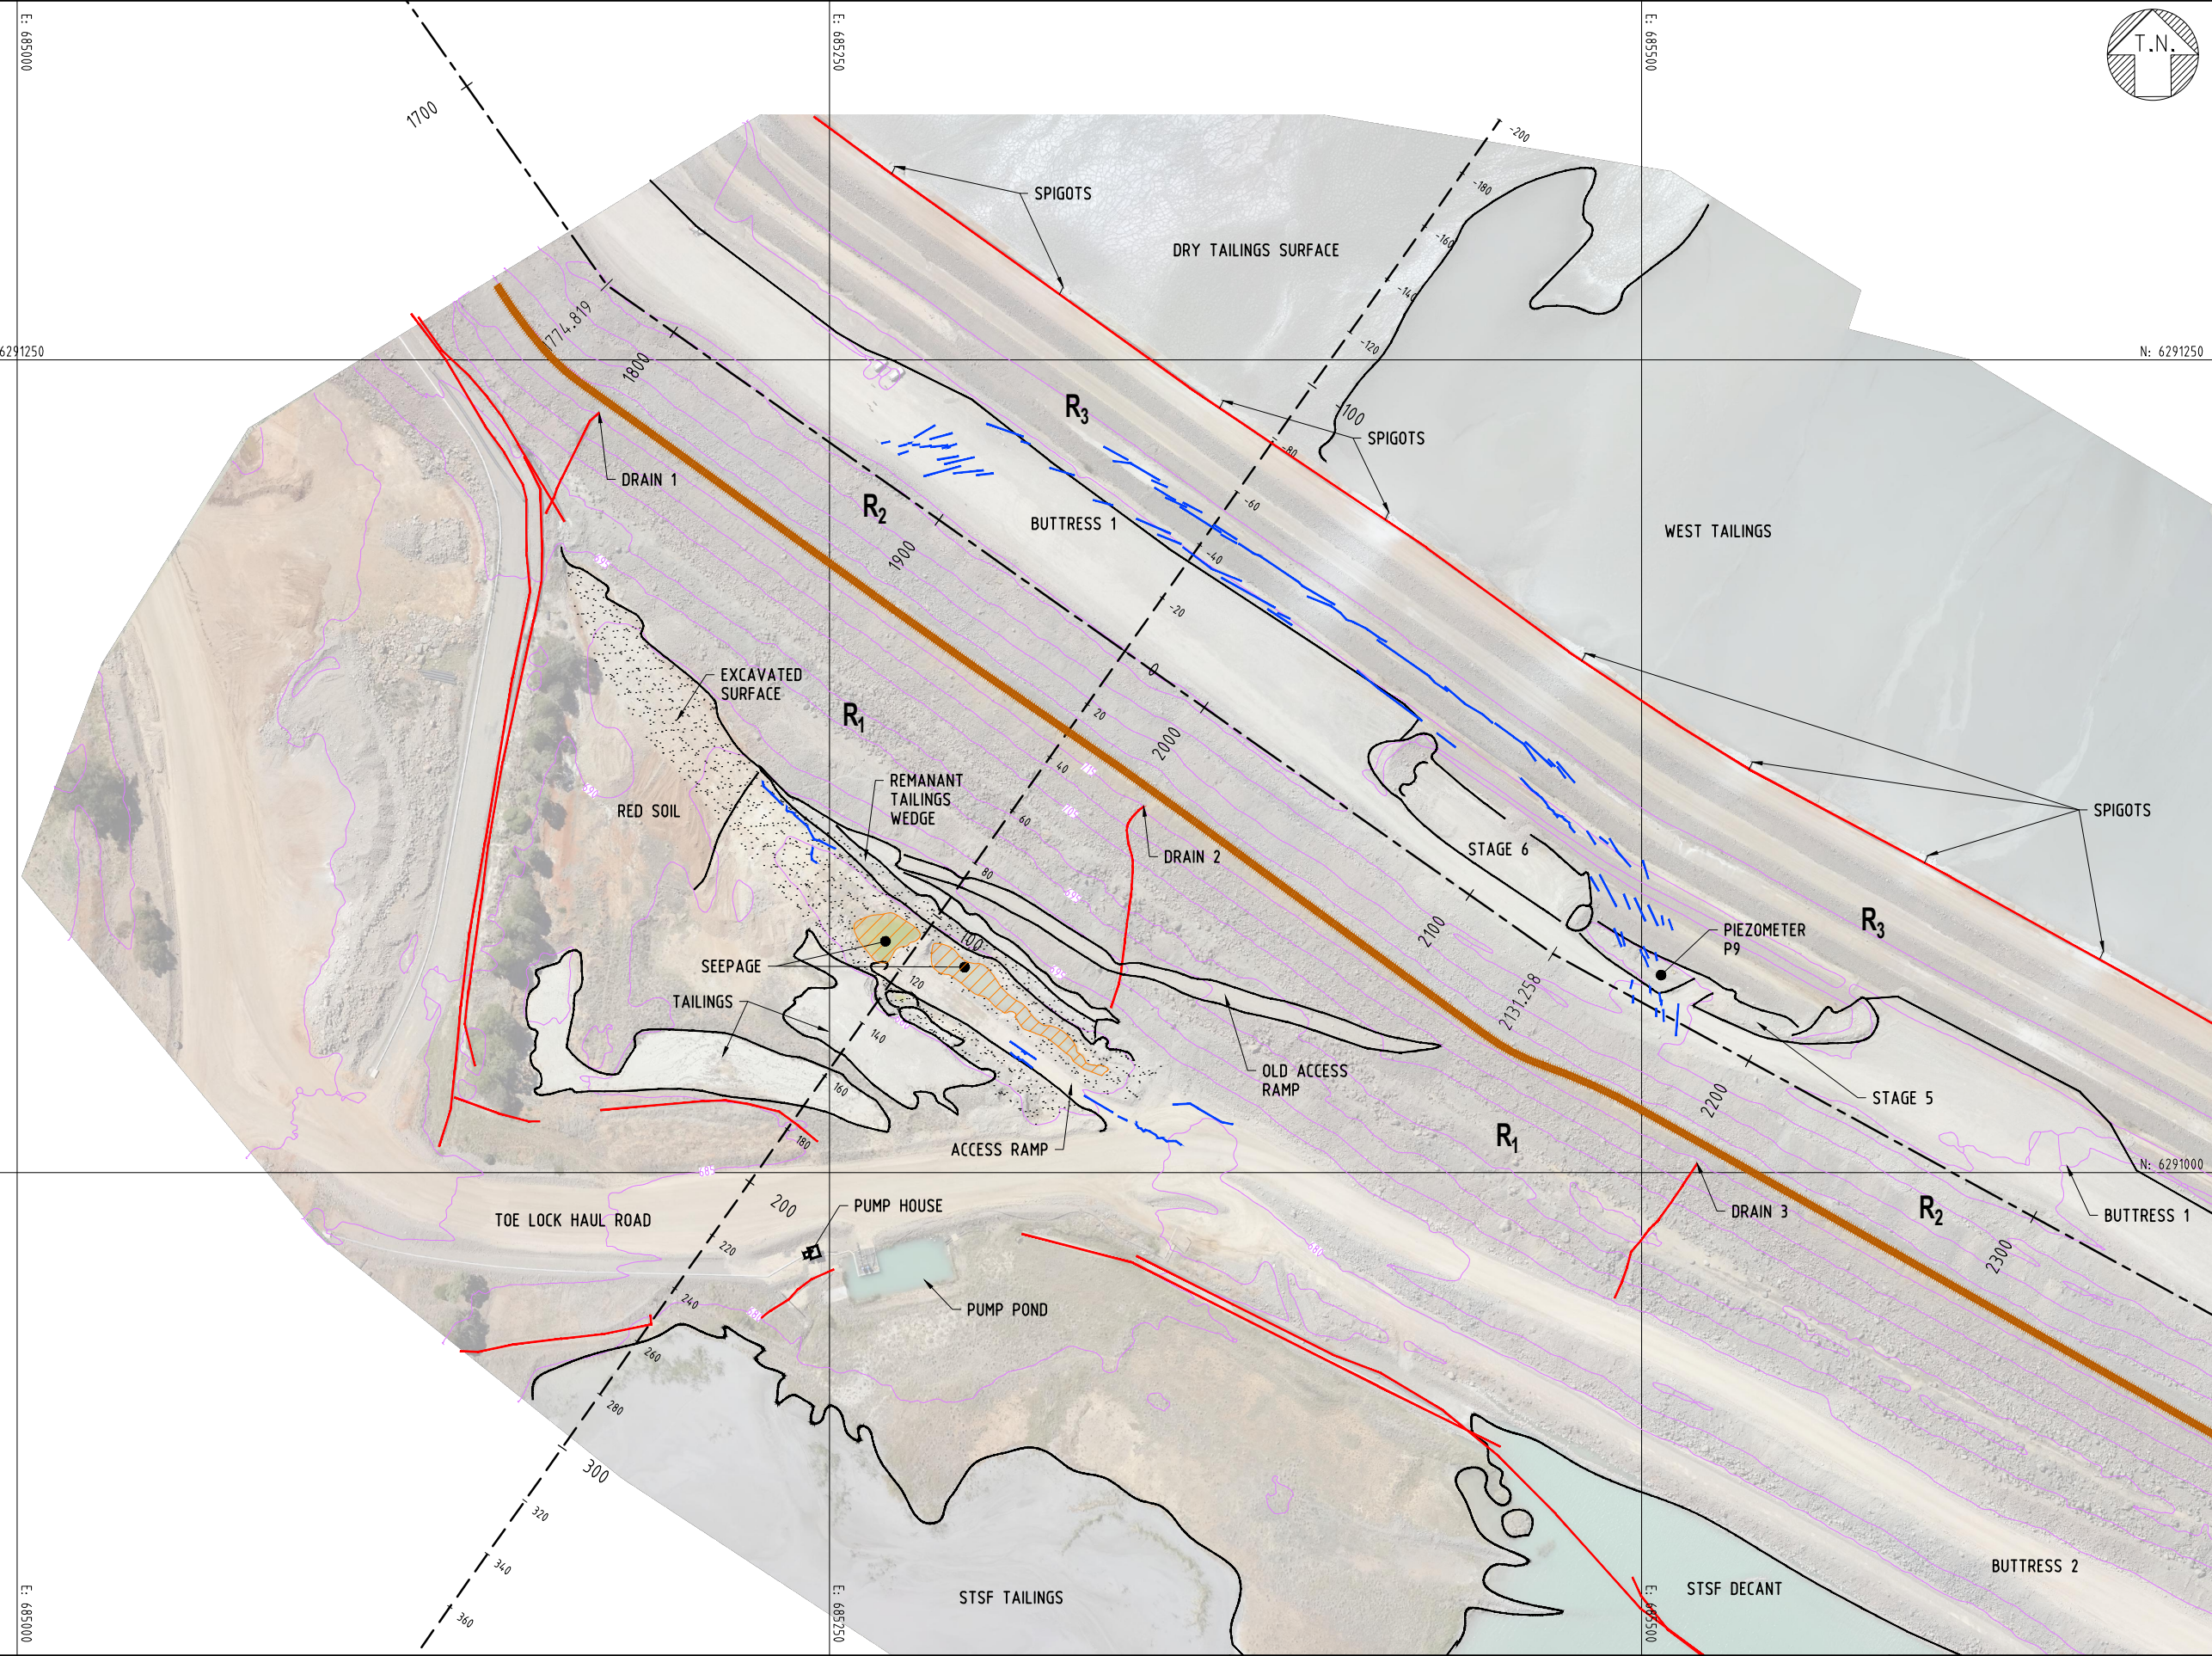
FIGURE B5

The marked cracks can be clearly seen in drone photography taken at 16:00 and marked on Figure B5 (Annexure BA).

- Cracking on Stage 1 Buttress extended diagonally from Stage 7 crest to edge as a 20m wide band of closed, 'en eschelon' cracks 5 to 10m long and 1 to 2m apart;
- The crack pattern on the Stage 7 crest was comprised of up to 10 individual cracks and was curved at either end;
- Cracks on Stage 7 crest were open 5 to 10cm, with no vertical displacement;
- Rocks falling into the Stage 7 crack could be heard after 15:00;
- Cracking on Stage 8 crest similar to Stage 7, but no sound could be heard;
- No cracking observed on Stage 9 crest and none reported by others on Stage 10;
- Longitudinal crack extended by 20m (2 to 5cm wide) on western side;
- Rupture in haul road on eastern side of borrow area at toe was 20m long;
- Significant cracking on excavated batter in old borrow area at toe; and
- Rocks could be heard rolling down batter near end of site visit at 16:30.

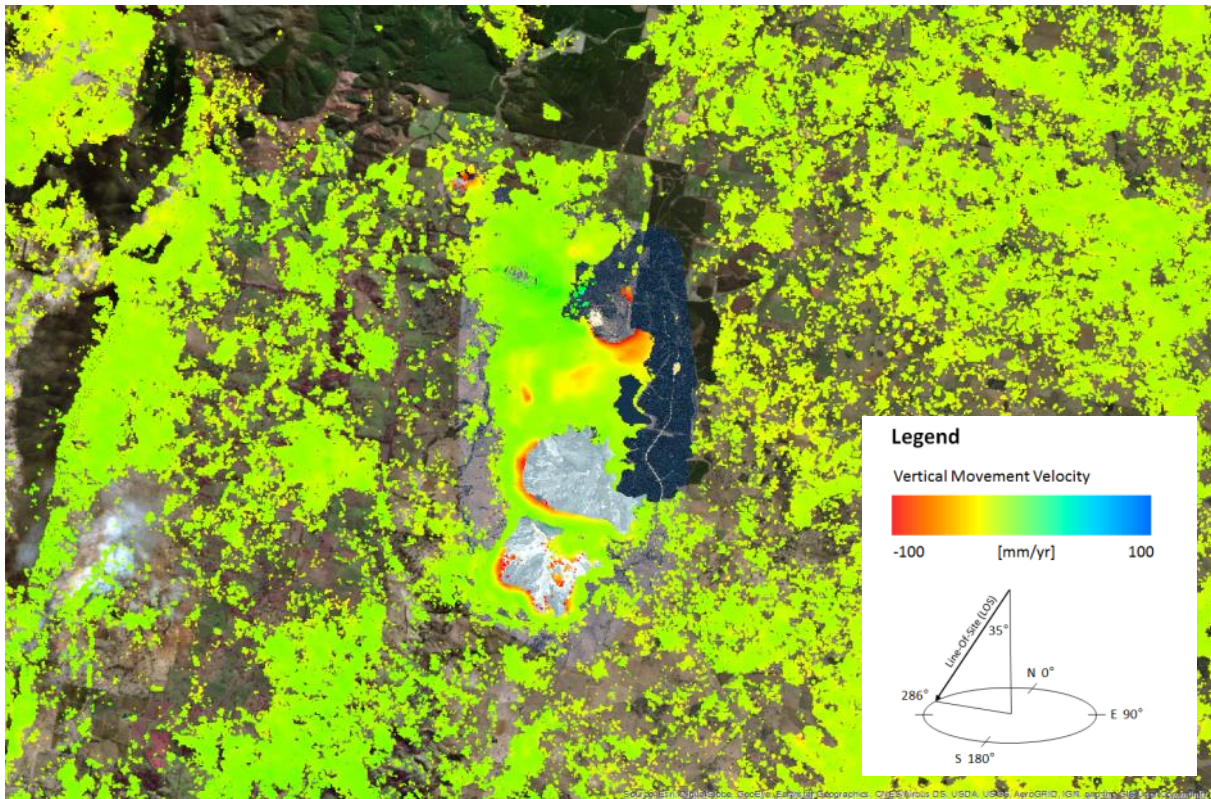
Figure 9: Surface movement map over Cadia Mine region (13/01/2017 – 25/02/2018). © Airbus Defence and Space GmbH 2018.

The surface movement situation within the area of interest exhibits regional subsidence effects; especially over the (southern) tailings ponds and East of the open pit (see orange/red areas in Figure 9). Most of the elongated subsidence pattern parallel to the tailings pond dams is related to a drying process and the related shrinking of the tailings material. The dominating pattern of subsidence at the North cannot be interpreted because of missing additional information. Some small-scale subsidence patterns are linked to dumpsites. They likely indicate a typical compaction process of the dumped material.

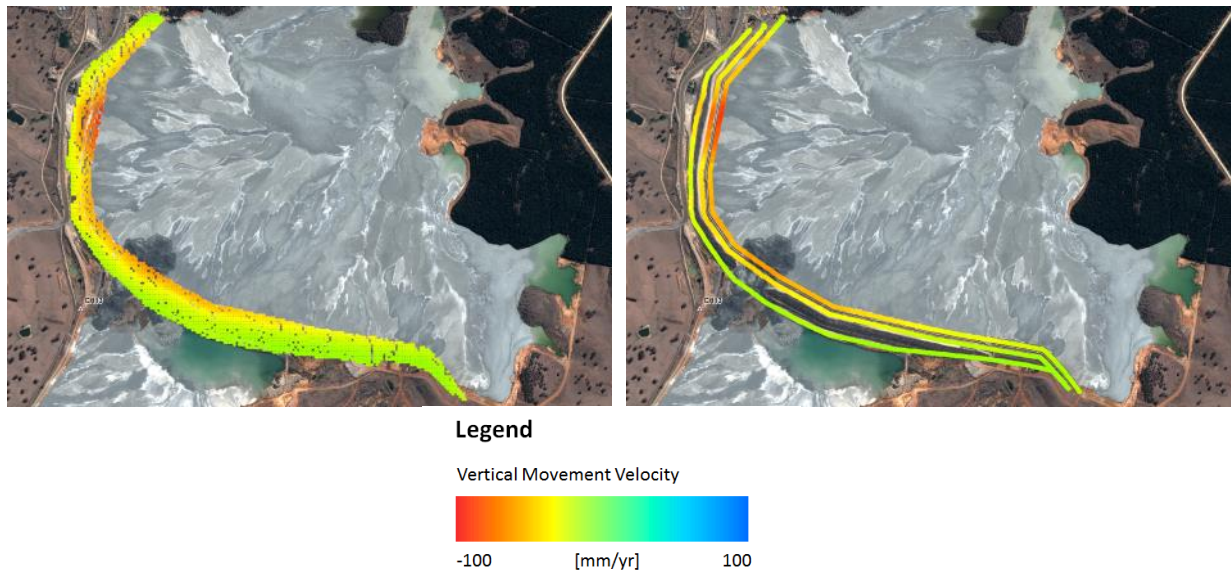
Airbus has been asked to conduct additional analysis at the breached tailings pond dam. This section summarizes the results. In order to distinguish between adjacent measurement pixels representing shrinking tailings material inside the pond and the dam itself a mask has been defined as provided on the left-hand side of Figure 10. Centre lines along *Toe1*, *Stage7* and *Stage10* were provided by the client to be further analysed. Along these polylines the SMM measurement pixels within a search radius of 20 m were allocated and averaged to a single value. Figure 10 shows the surface movement map masked out for the dam and the associated averaged values along the polylines. Clearly visible are subsidence zones in the North and in the South, representing the location where the dam recently breached.

Figure 10: **Left:** Surface movement map (13/01/2017 – 25/02/2018) masked for the dam area only. **Right:** Allocated and averaged values along the polylines. Background Pléiades scene acquired 17/03/2018. © Airbus Defence and Space GmbH 2018.
