Appendix B: History of NTSF

In the late afternoon of Friday 9 March 2018, following the identification of cracks on the dam crest earlier in the day, a slump occurred on the western side of the southern embankment of the NTSF.

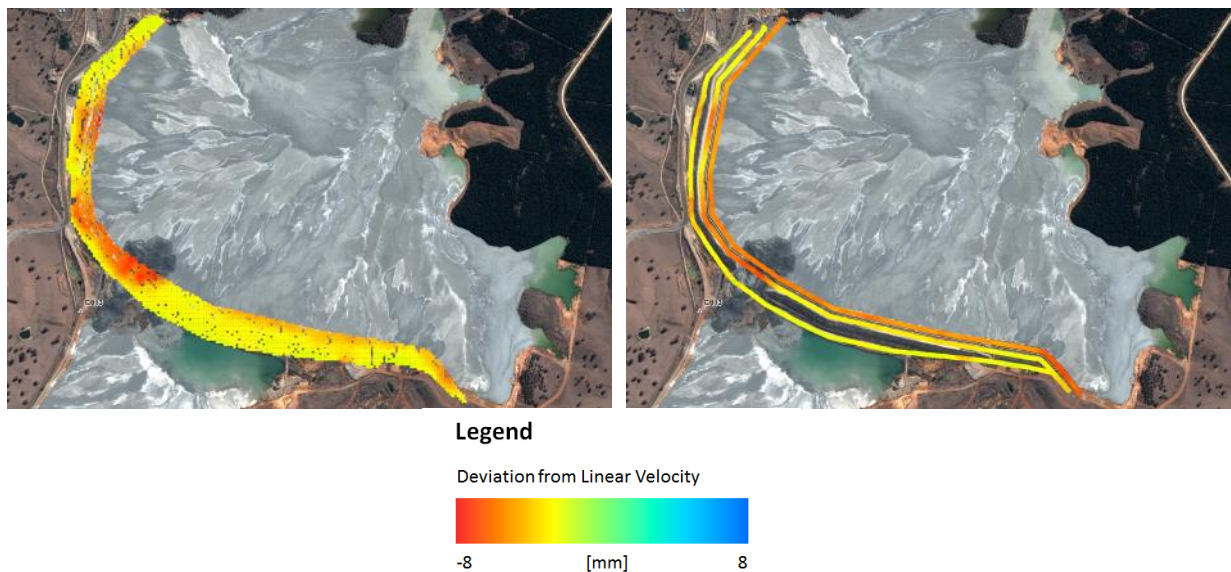
Figure 11: **Left:** Temporal deviation map (13/01/2017 – 25/02/2018). **Right:** Allocated and averaged values along the polylines. Background Pléiades scene acquired 17/03/2018. © Airbus Defence and Space GmbH 2018.

The analysis of the average velocity map (Figure 10) alone does not lead to a complete understanding of a critical deformation process. Therefore, an additional parameter has been extracted: The temporal deviation of the displacement values. These highlight those zones where the displacement values vary in time. This can be - among others - caused by accelerated movement behaviour. Figure 11 shows high deviation values (red zones) exactly at

the location where the dam failed in March 2018 and at a second location further north. In other words: the averaged velocity values may not necessarily reveal critical deformation behaviour in time. Hence, other parameters should be used for further analysis, like the deviation from linearity.

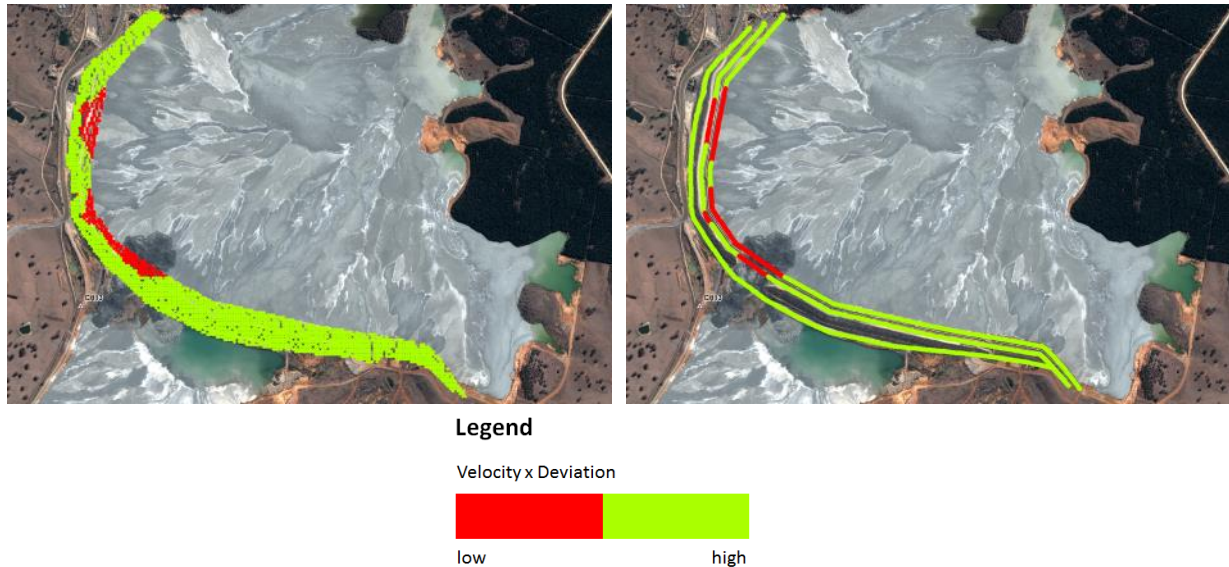
Figure 12: Left: Illustration of Velocity x Deviation product map (13/01/2017 – 25/02/2018). **Right:** Allocated and averaged values along the polylines. Background Pléiades scene taken 17/03/2018. © Airbus Defence and Space GmbH 2018.

As written above, large deviation values may be among others caused by movement changes in time. Such deviation values can be caused by several reasons, for example by strong varying (noise) time series at low level of velocity. To highlight areas characterized by strong movement (critical movement) and strong temporal movement deviation (acceleration) Figure 12 shows an illustration of the mathematical product of ‘velocity’ and ‘deviation’. This map classifies in red where strong and temporally variable deformation occurred. The zone of dam failure is clearly correlated. Other “red” zones further north are identified in addition.

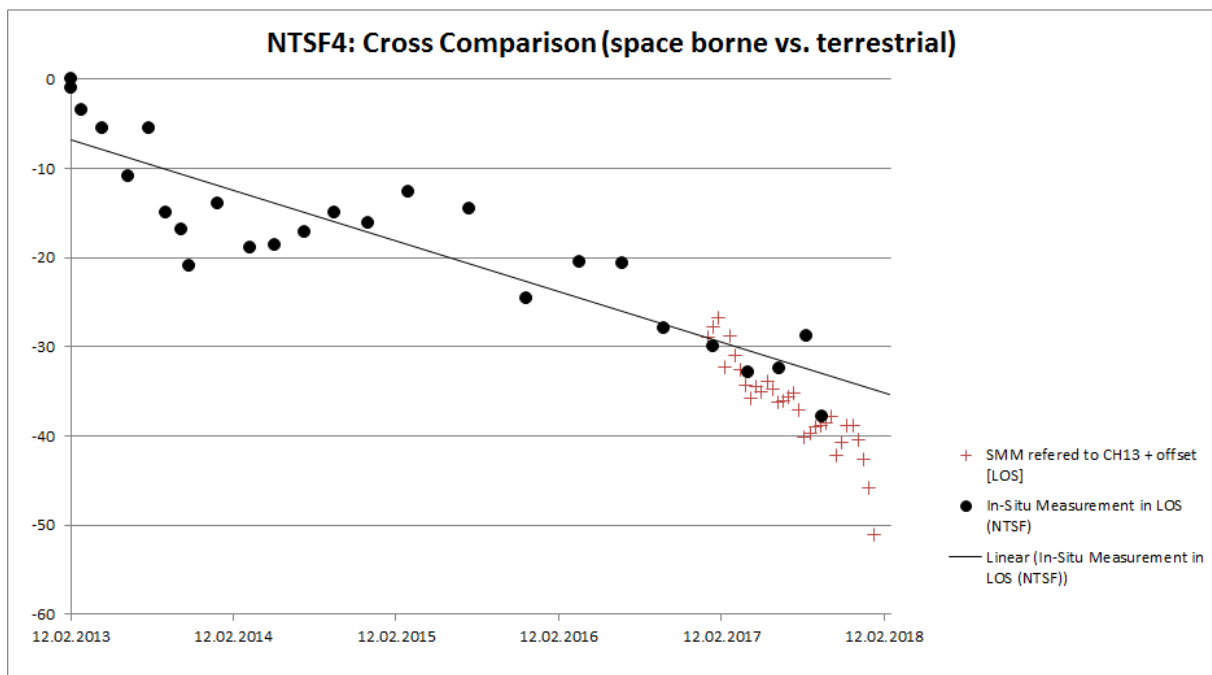
The prisms called *NTSF4*, *NTSF5* and *NTSF6* are located over the failure zone of the dam and therefore these are of special interest for further analysis. Figure 14, Figure 15 and Figure 16 show joined time series at these prism locations. Space borne and the terrestrial derived time series have a different character in terms of measurement noise. It seems the terrestrial survey results are characterized by higher variation in time (noise). The terrestrial observation is characterized by a lower measurement repeat frequency than the space borne data. Unfortunately, the terrestrial and space borne observations just have few temporally overlapping observations. Hence, it is difficult to correlate both. Nevertheless, all three joined time series show an overall match in terms of an ongoing subsidence during the observation period. The SMM measurements reveal a movement acceleration starting at the end of 2017. Such a sudden increase could potentially act as an indicator for a dam failure and may have been used as an alert indicator prior to the breach.

Figure 14: Plot of terrestrial survey results and allocated and averaged SMM velocity at prism NTSF4.

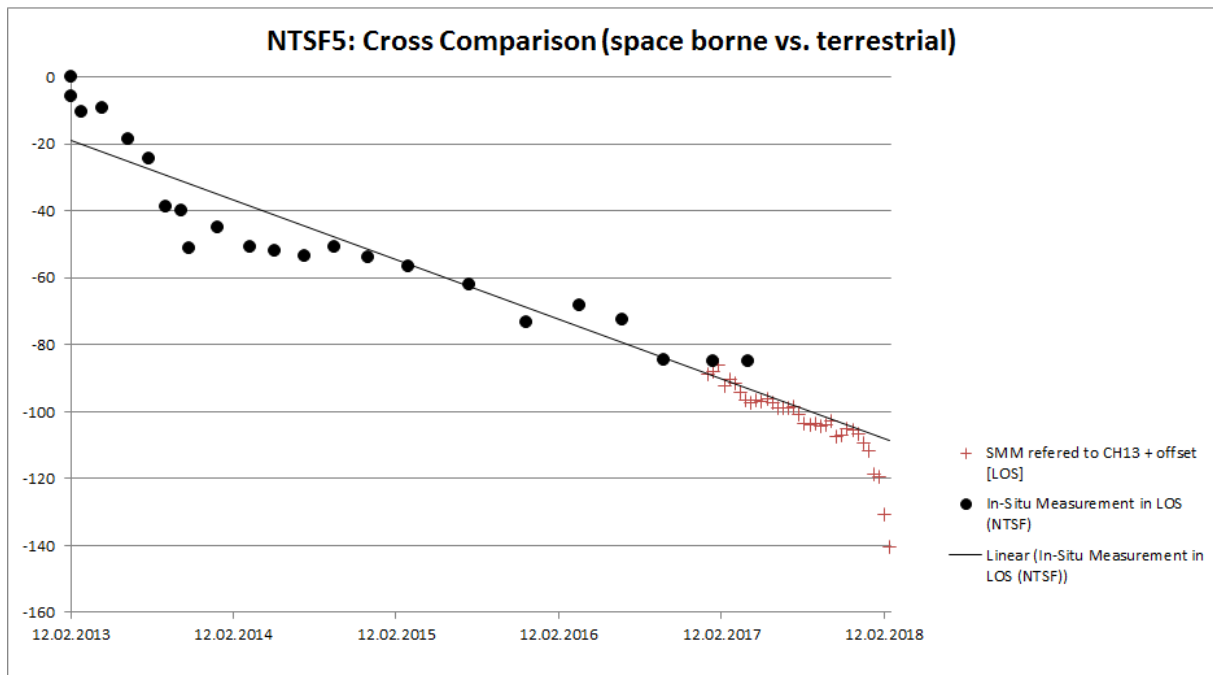
Figure 15: Plot of terrestrial survey results and allocated and averaged SMM velocity at prism NTSF5.

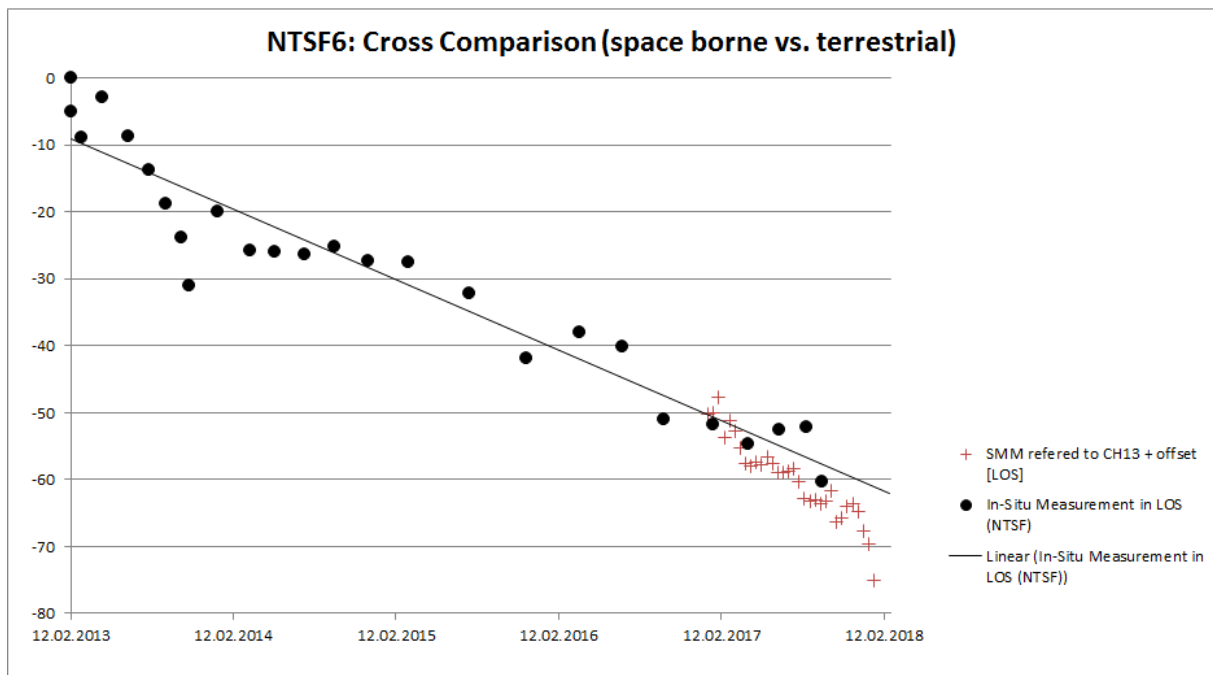
Figure 16: Plot of terrestrial survey results and allocated and averaged SMM velocity at prism NTSF6.

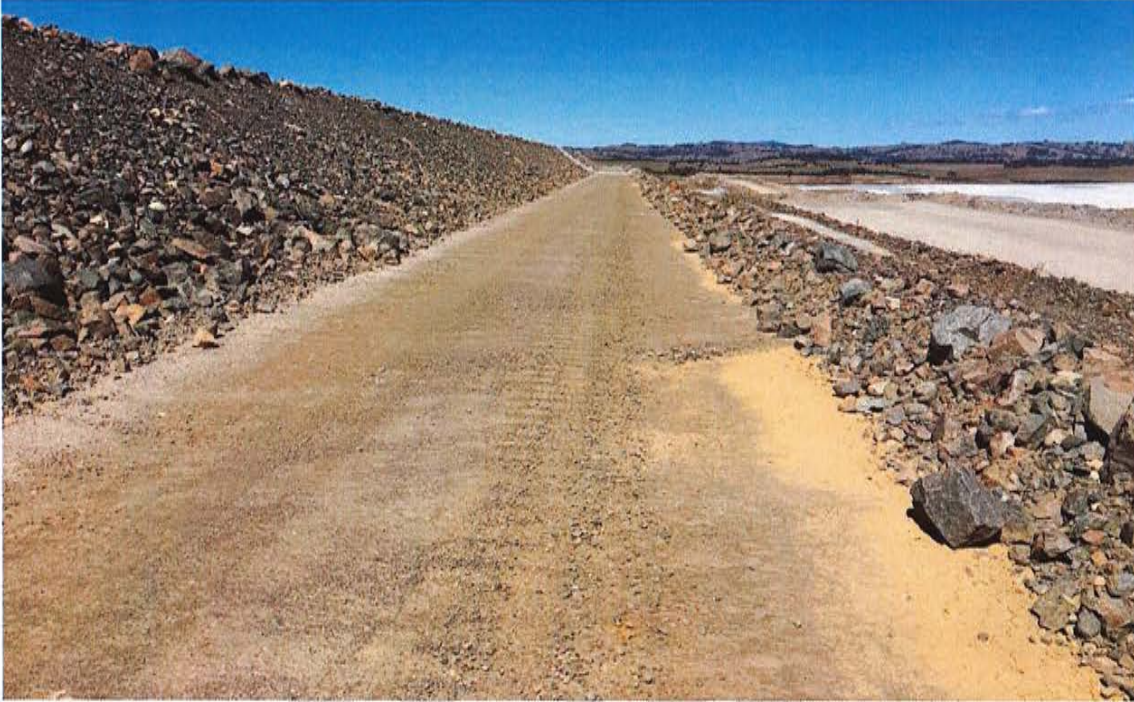
Looking from Stage 9 crest down across Stage 8 and Stage 7 and Stage 1 Buttress, looking south-easterly (IMG_2531)

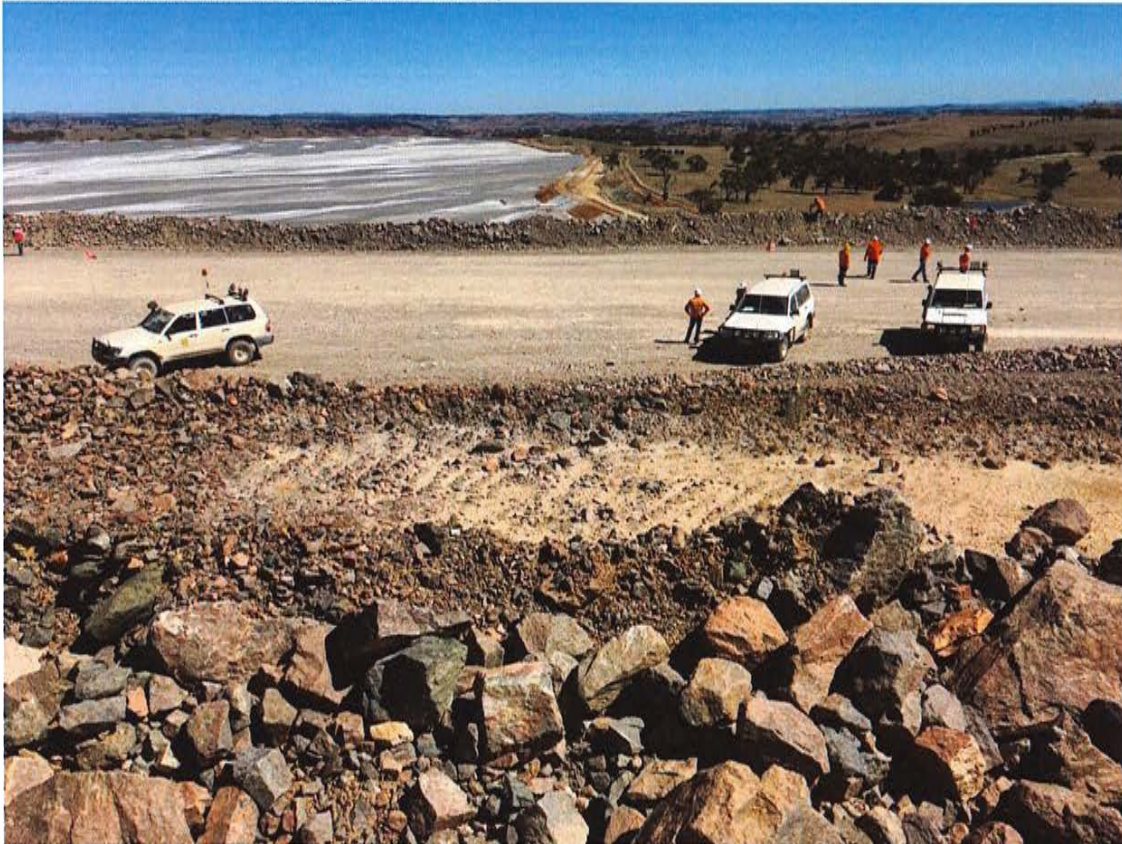
From Stage 9 looking down onto Stage 8 crest, and Stage 7 embankment Stage 1 buttress below, looking south-east (IMG_2528)

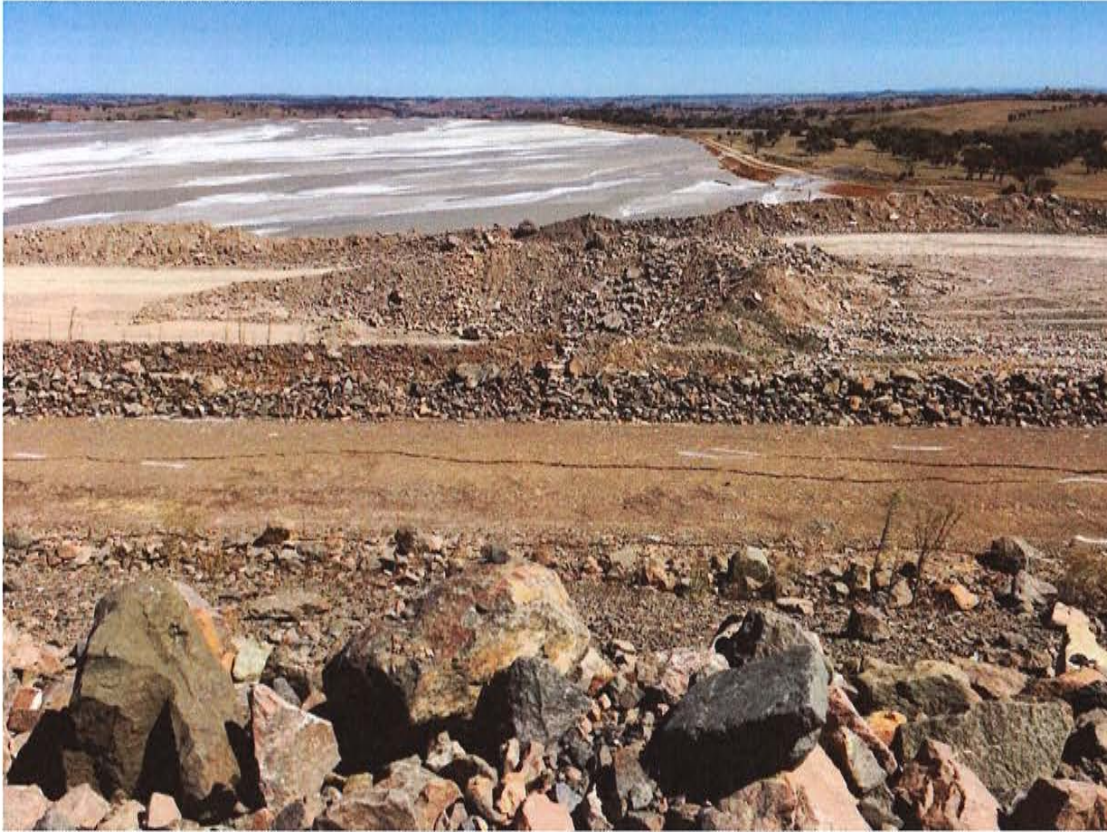
From Stage 9 looking down onto Stage 8 Crest and Stage 1 Buttress below, looking southwest (IMG_2529)

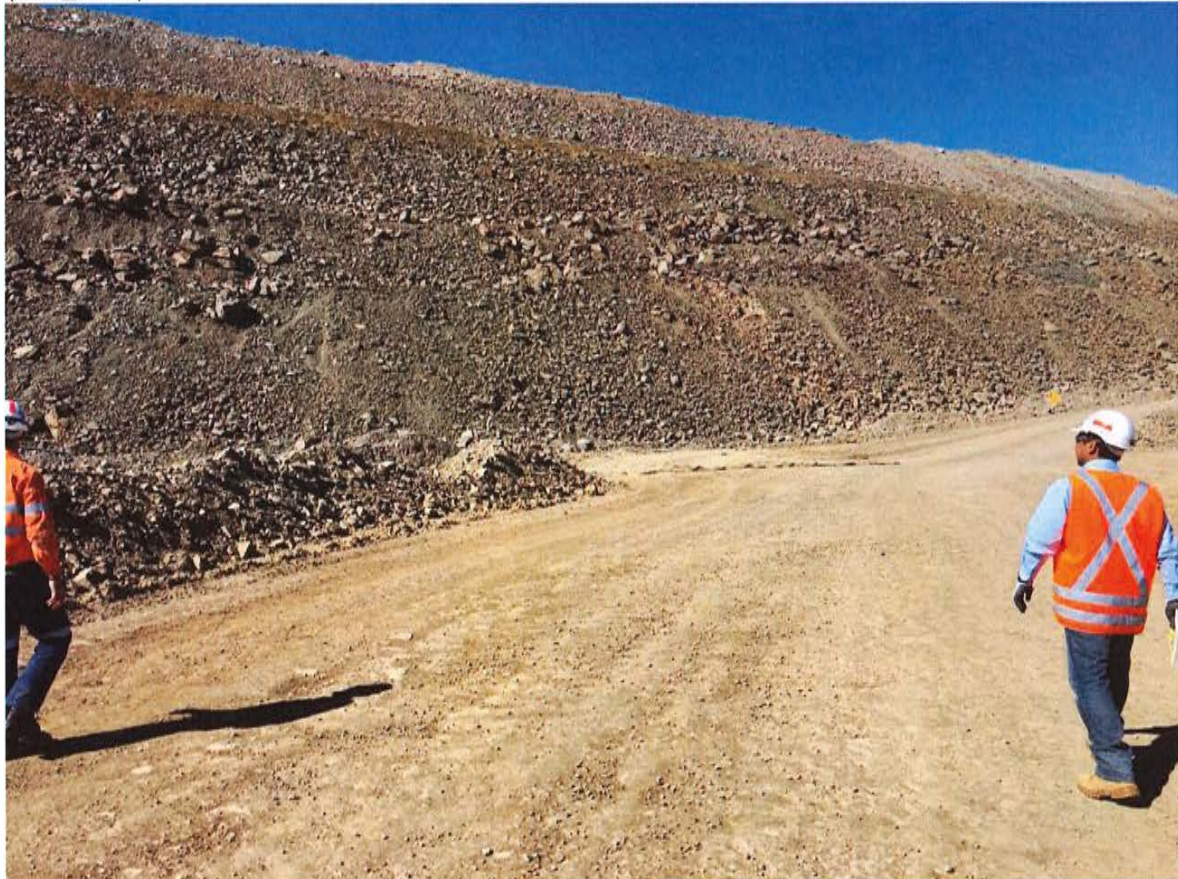
16. Ground rupture was noted to the left (eastern side) of the old borrow pit at the toe of the dam. Rupture was approximately 20m long. I did not approach closer than 30m to this rupture for my own safety reasons (personal assessment).

Initial approach to toe area, ground rupture noted at dam toe, looking north-easterly (IMG_2536)

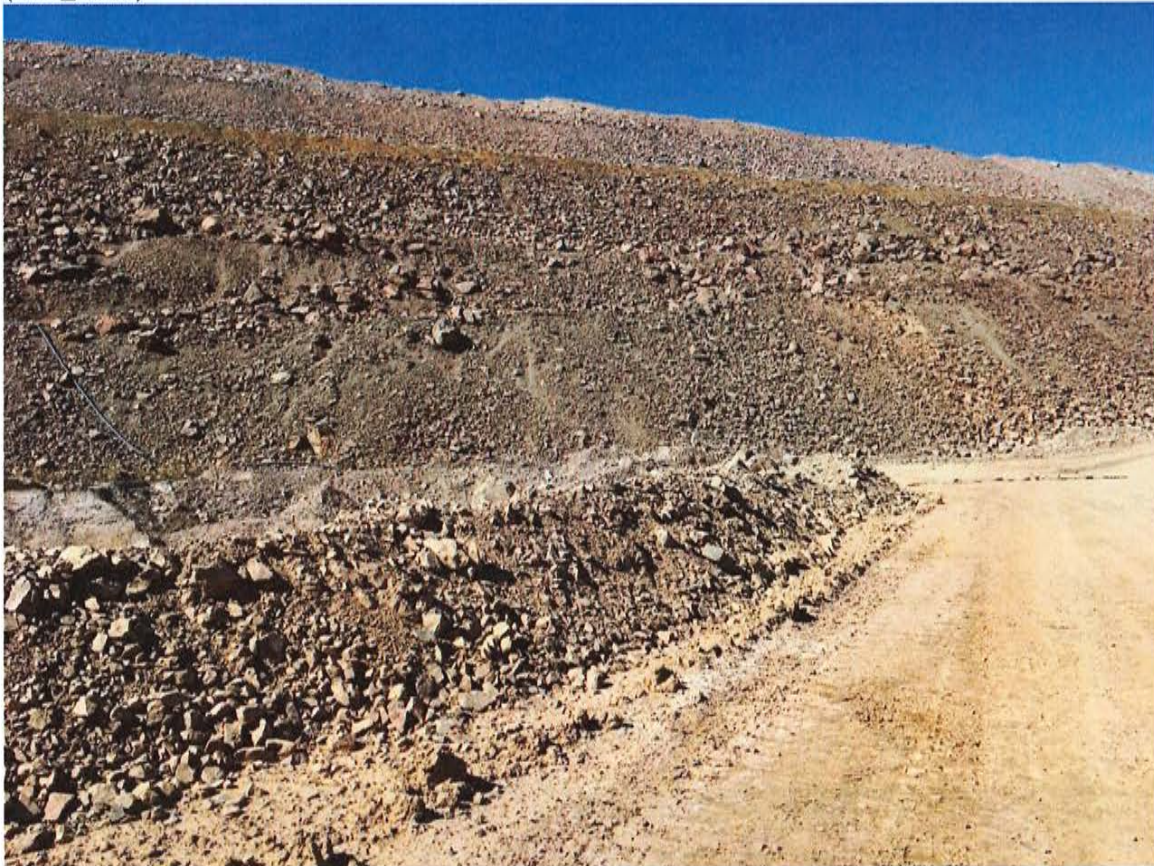
Toe area, linear cracking on access road (ground rupture), looking North-easterly (IMG_2543)

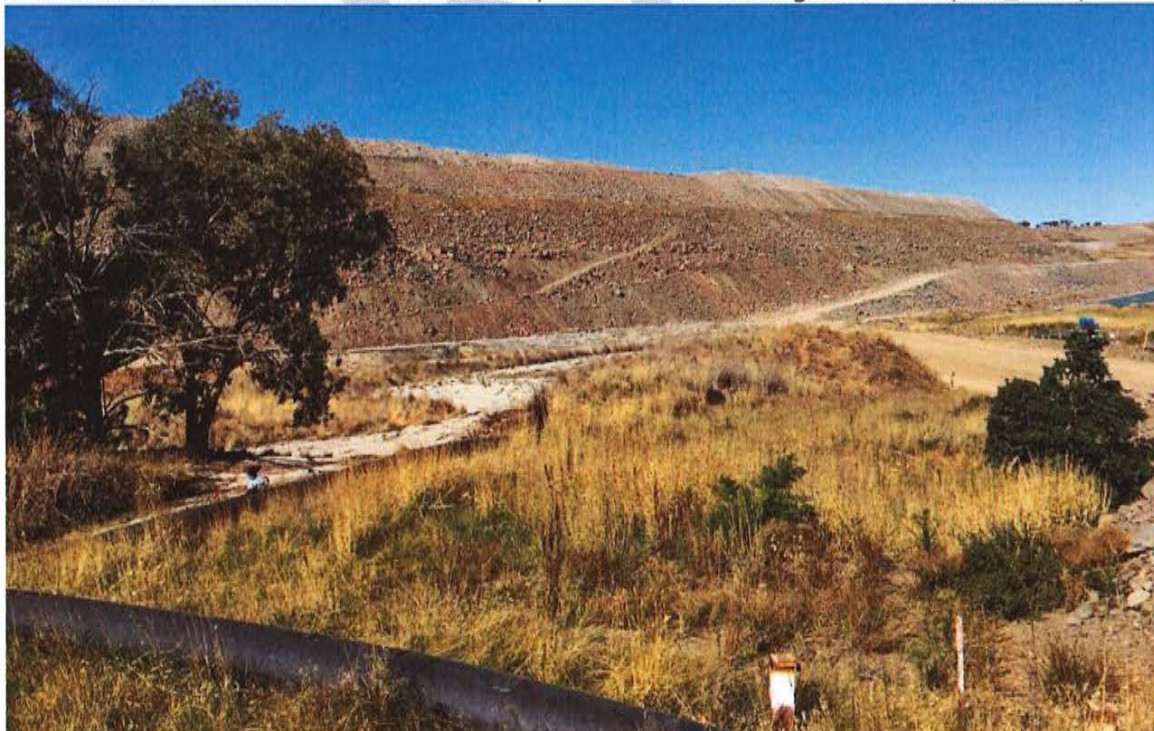
Relocated to a distance from the toe area, overall view looking Northeast (IMG_2544)

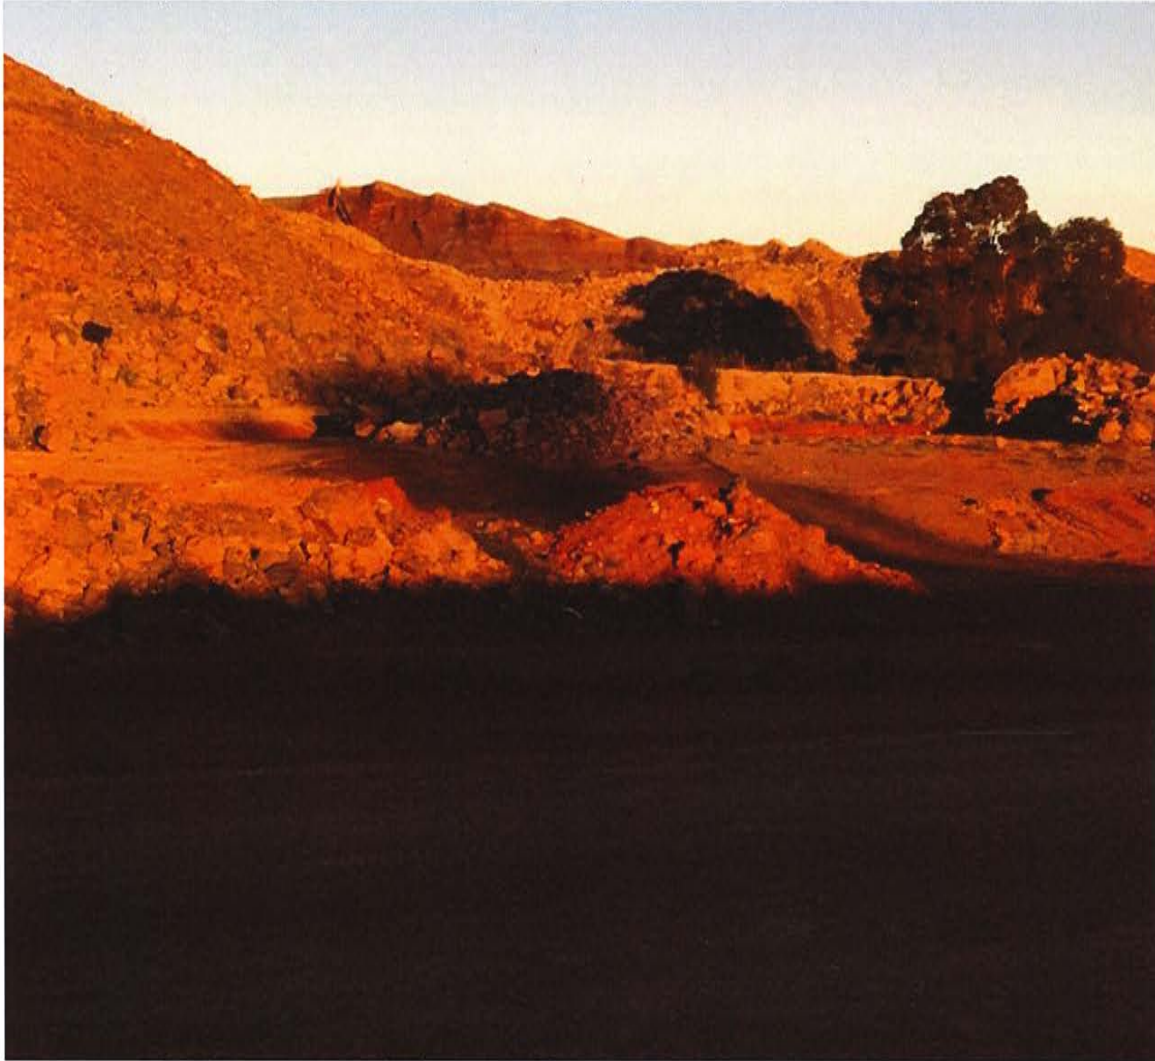
Photo looking easterly at side of slumped area (by Peter Lord)

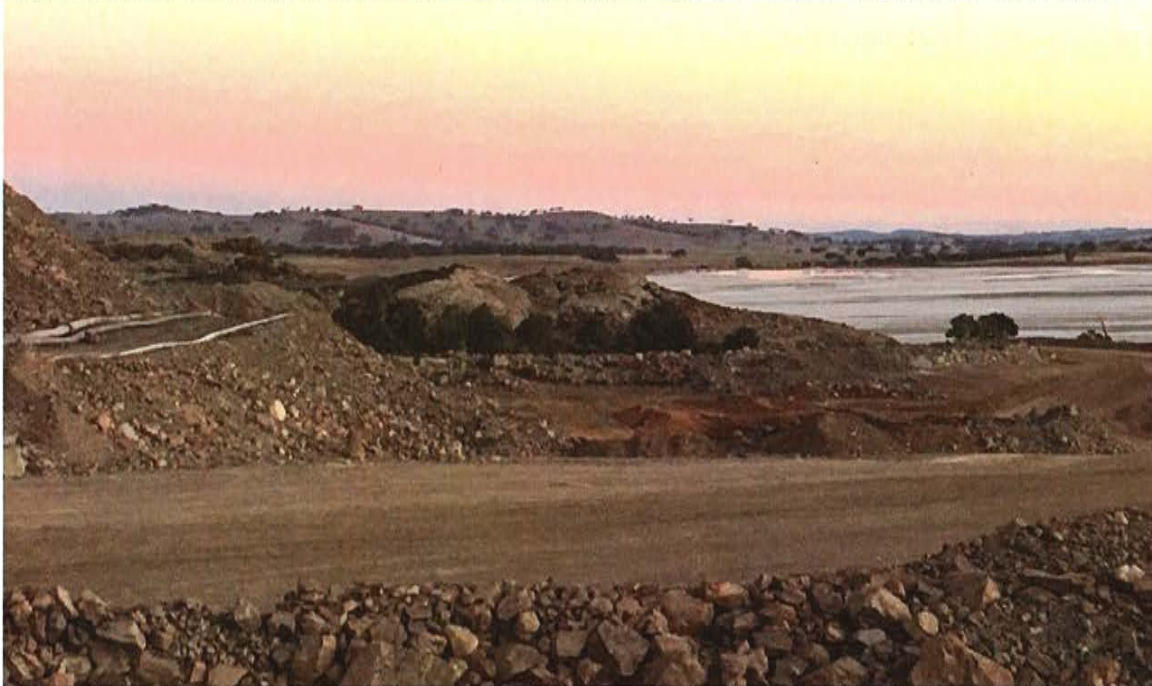
Photo looking easterly at side of slumped area (picture correction applied for low light)

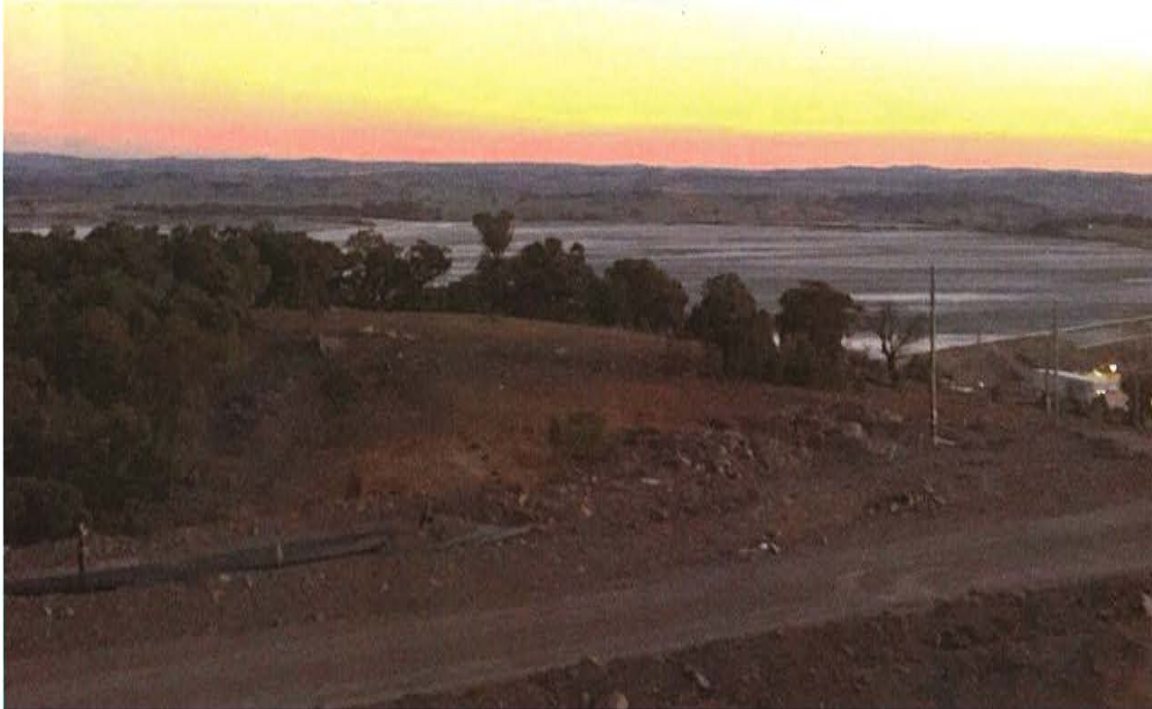
Photo looking over NTSF impoundment area post slump (picture correction applied for low light)
